# Building Condition Assessment Report

Broadway Theatre  
Monticello, NY

*Tectonic Engineering Consultants, Geologists, & Land Surveyors D.P.C.*  
Tectonic Work Order No.: 9294.01  
September 28, 2023

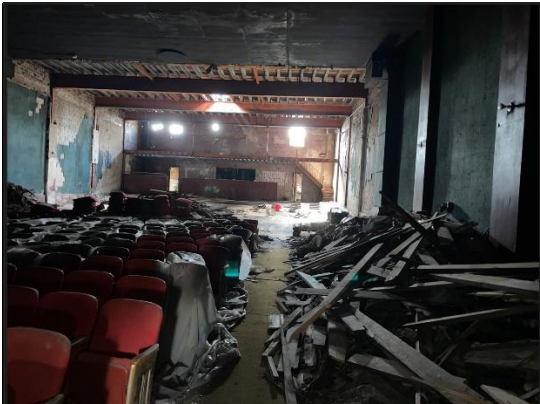
**Photograph # 1**

Looking south toward projection room and front of building.

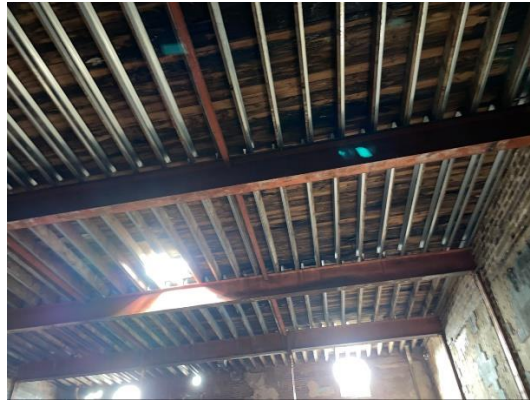
**Photograph # 2**

Existing wood joist on upper roof sistered with new CFS joists.

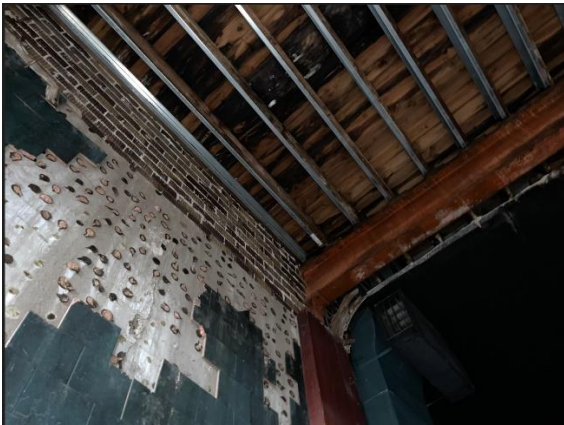
**Photograph # 3**

All the exposed structural steel elements were found to be in good condition. No signs of major deterioration but rust was noticed on the top and bottom flanges of the girders, most likely due to exposure to water leaking from the roof. The building is vacant and without and running utilities, so the lack of any lighting prevented any detailed visual observations of the girder & connections to the column as they are located at roof level.

Steel girder to column connection. Wood and CFS joists & T&G roof deck above

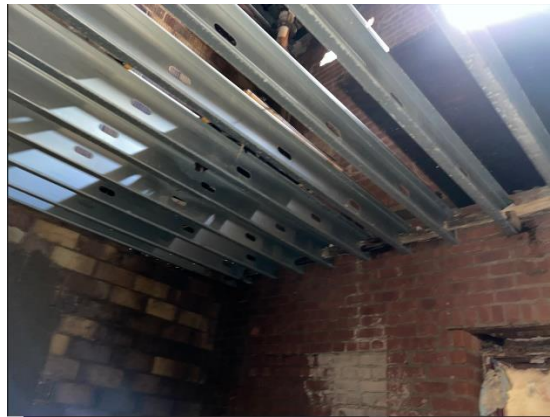
**Photograph # 4**

Bottom view of new projection room CFS floor joists.

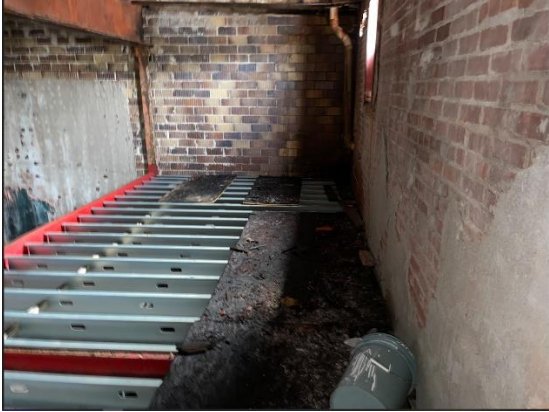
**Photograph # 5**  
Top view of new projection room CFS floor joists.

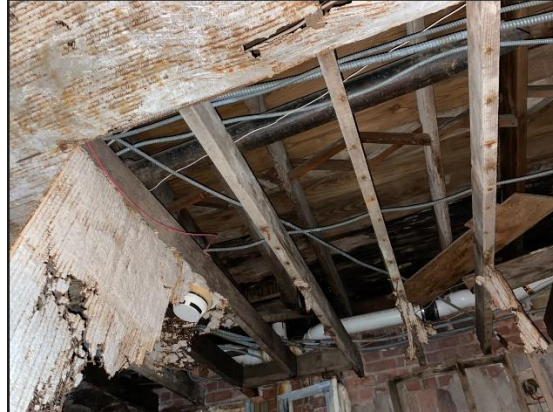
The front lobby/ticket booth area is located at the front of the building under the lower roof. The floor in the lobby is a concrete slab that is in good condition, the roof is wood joists spanning from masonry wall to masonry wall with a wood roof deck. The existing drop ceiling has extensive water damage from roof leaks, some of the drop ceiling has collapsed and water is still dripping from the roof damaging what remaining ceiling is still there. The only hazard in working in this area is the potential for more debris to fall from the ceiling. Most of the paint and drywall has moisture damage and is cracking.

**Photograph # 6**  
Water damaged collapsed ceiling in lobby. Roof deck by roof drain saturated.

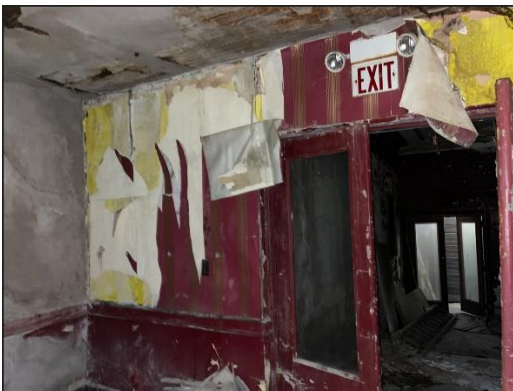
**Photograph # 7**  
Water damaged walls and ceiling in lobby.

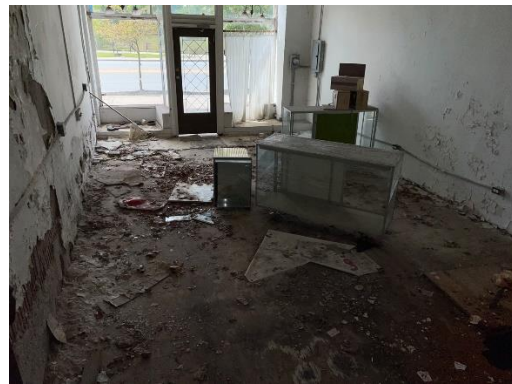
**Photograph # 8**  
Water damaged floor and walls in Vacant Storefront #1.

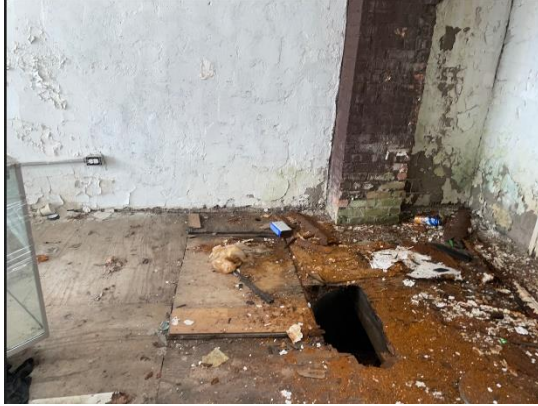
**Photograph # 9**

The Vacant Storefront #1 is located at the southwest corner of the building. The space shares the lower roof with the lobby which is wood joists spanning masonry wall to masonry wall with a wood roof deck. The floor in the Vacant Storefront #1 is wood joists with plywood decking over a concrete slab crawlspace. Roof leaks have caused some of the ceiling to collapse from water damage and the northwest corner of the roof has extensive water damage on the plywood floor deck. The plywood floor deck in the northwest corner of the room has rotted away and there is a massive hole that leads to the crawlspace. If entering for a hazmat survey, 8'x8' section of the northwest corner of the room should be avoided. Most of the paint and drywall has moisture damage and is cracking.

Hole in floor in Vacant Storefront #1. Damaged plywood floor in northwest corner of room.

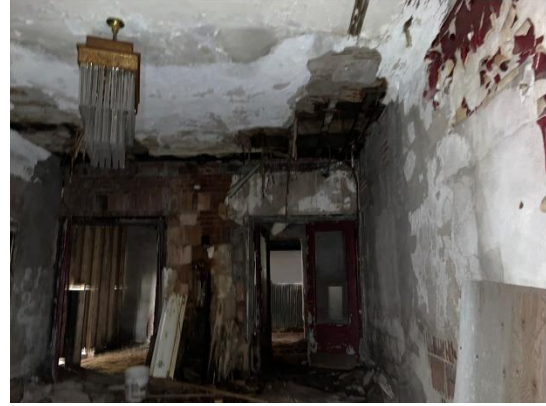
**Photograph # 10**

Water damaged walls & ceiling. Partial ceiling collapse.

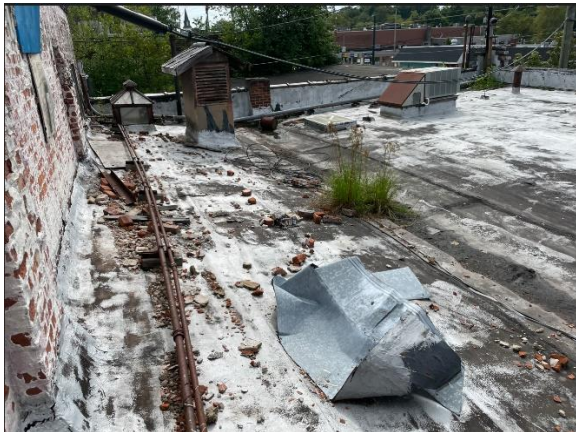
**Photograph # 11**

The lower roof as detailed in the previous sections is wood joists spanning from the masonry walls with a wood deck. The roof slopes and forms a valley about 5' south of the wall separating the upper and lower roof. There was water pooling in the valley and there is vegetation growing on the roof, indicating the membrane has been compromised. The roof membrane is visibly worn and has noticeable soft spots where water was infiltrated the membrane. As mentioned in section 3.1 it is detailed that the front parapet is deflecting where the parapet flashing membrane is separated from the masonry due to the deflection. Caution should be taken when working on the lower roof as the condition of the roof joists were not able to be verified, however the presence of extensive roof leaks and damage to the ceilings below would indicate that the roof joists have some amount of water damage.

Lower Roof – Vegetation growing out of roof drain. Sediment build up in valley.

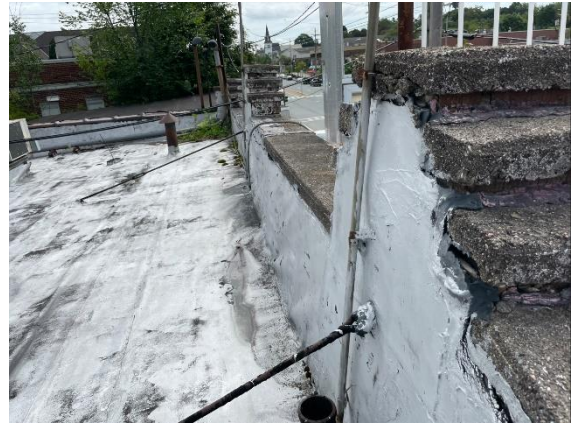
**Photograph # 12**

the wood roof joists. Poor condition of the roof may have caused some deterioration of these connections causing the parapet to begin to deflect due to the loading from the sign. The deflecting of the parapet has also caused the waterproofing membrane to become separated from masonry, potentially further damaging the roof structure by allowing additional water filtration.

Deflecting parapet at front of building

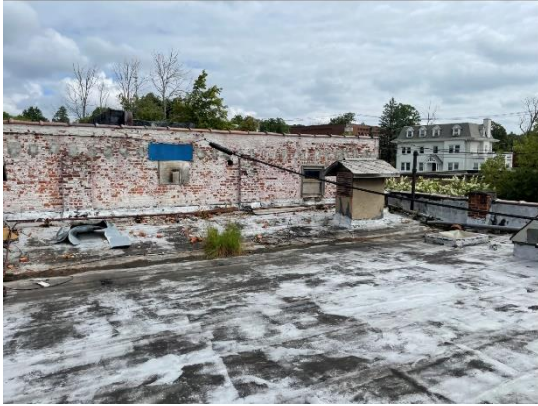
**Photograph # 13**  
Wall to upper roof. North looking view of lower roof

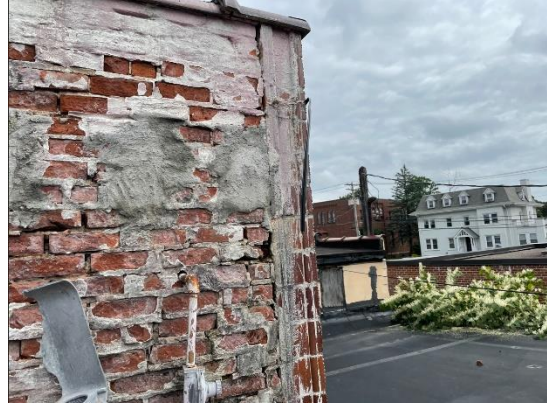
The upper roof façade masonry is in moderate to poor condition. There are several bricks missing and the façade bricks that remain are noticeably weathered and in need of repointing.

**Photograph # 14**  
Deteriorated masonry at exterior wall.

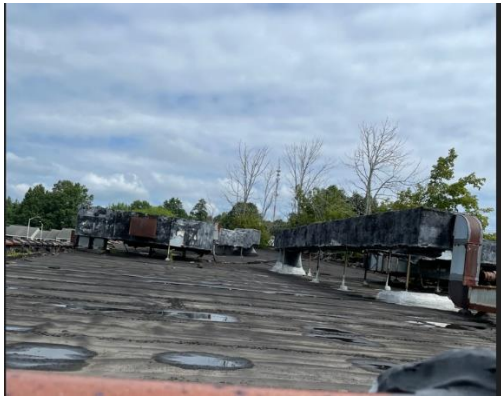
**Photograph # 15**  
North looking view of upper roof. Pooling visible on damaged roof membrane.

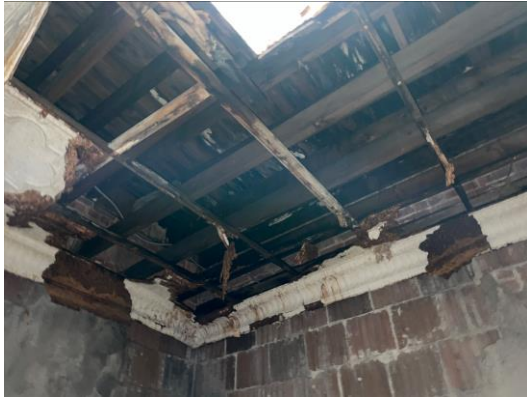
**Photograph # 17**

Ceiling of Vacant Storefront #2. Metal Ceiling collapsed from water damage and roof deck is visibly saturated.

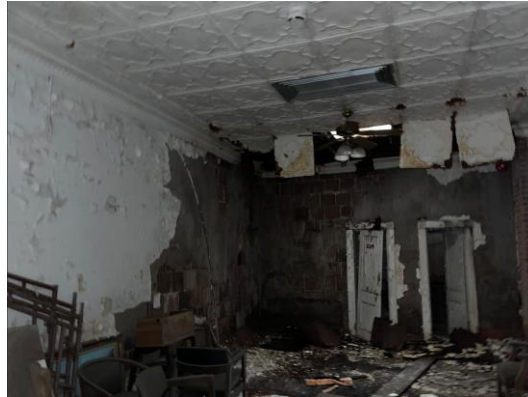
**Photograph # 18**

The Vacant Storefront #2 is located at the southeast corner of the building. The space shares the lower roof with the lobby and Vacant Storefront #1, which is wood joists spanning masonry wall to masonry wall with a wood roof deck. The floor in Vacant Storefront #2 is wood floor joists with plywood decking with an opening in the floor for access to the concrete slab crawlspace. Similar to Vacant Storefront #1, roof leaks have caused some of the decorative tin ceiling panels to collapse and there is extensive water damage to the plywood floor decking. The entire back half the storefront floor decking is oversaturated and rotting away. The back half of the space's floor system is compromised, if accessing for a hazmat survey only the first 10 feet from the front door should be used for sampling. A lot of the paint and parging on the walls have peeling, exposing the terracotta block walls.

View from front entrance of Vacant Storefront #2 looking to rear of space. Metal ceiling collapsed from water damage and floor decking in rear of room is visibly deteriorating.

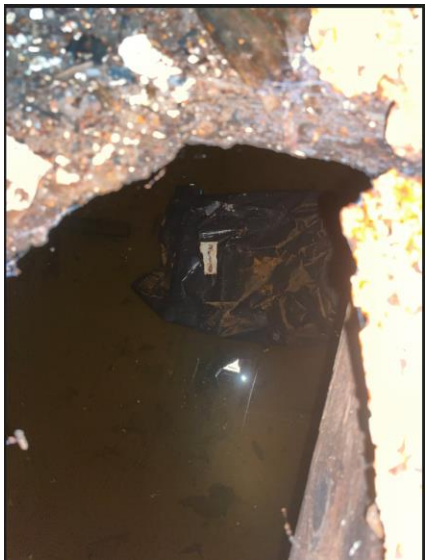
**Photograph # 19**

Water pooling under floor in crawlspace in Vacant Storefront #2.
