**Asbestos Containing Materials
(ACM) & Lead-Based Paint (LBP)
Survey Report**

**Broadway Theater
498 Broadway
Monticello, New York**

October 30, 2023
Work Order: 9294.01

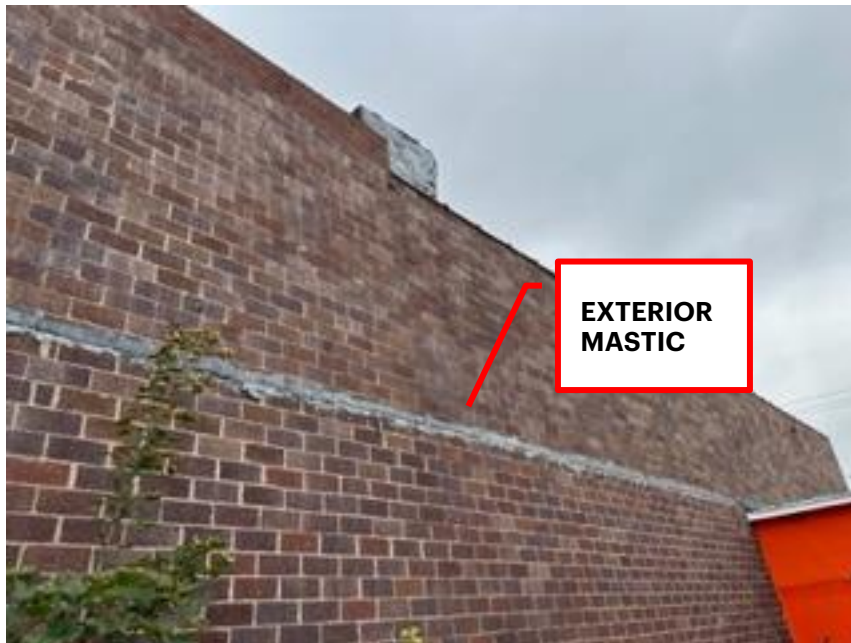
WALL MASTIC EXTERIOR

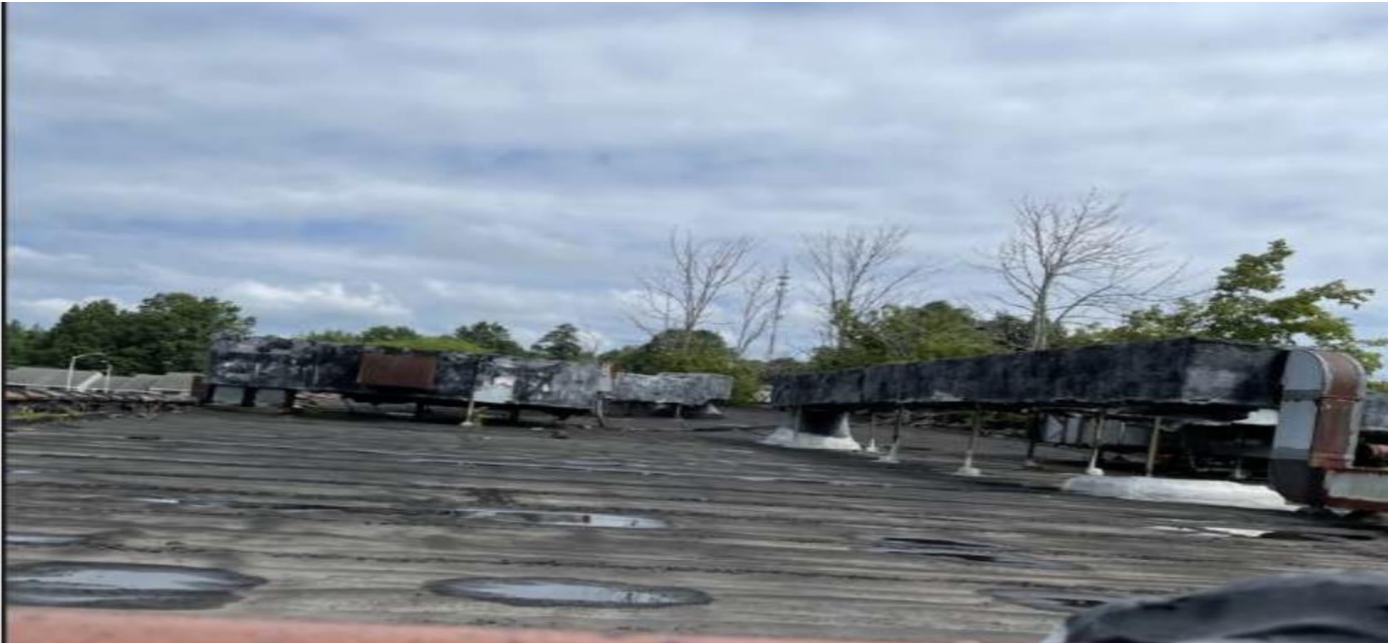
MAIN ROOF, POOR CONDITION; ASSUME ALL ROOF/MASTICS TO BE ACM

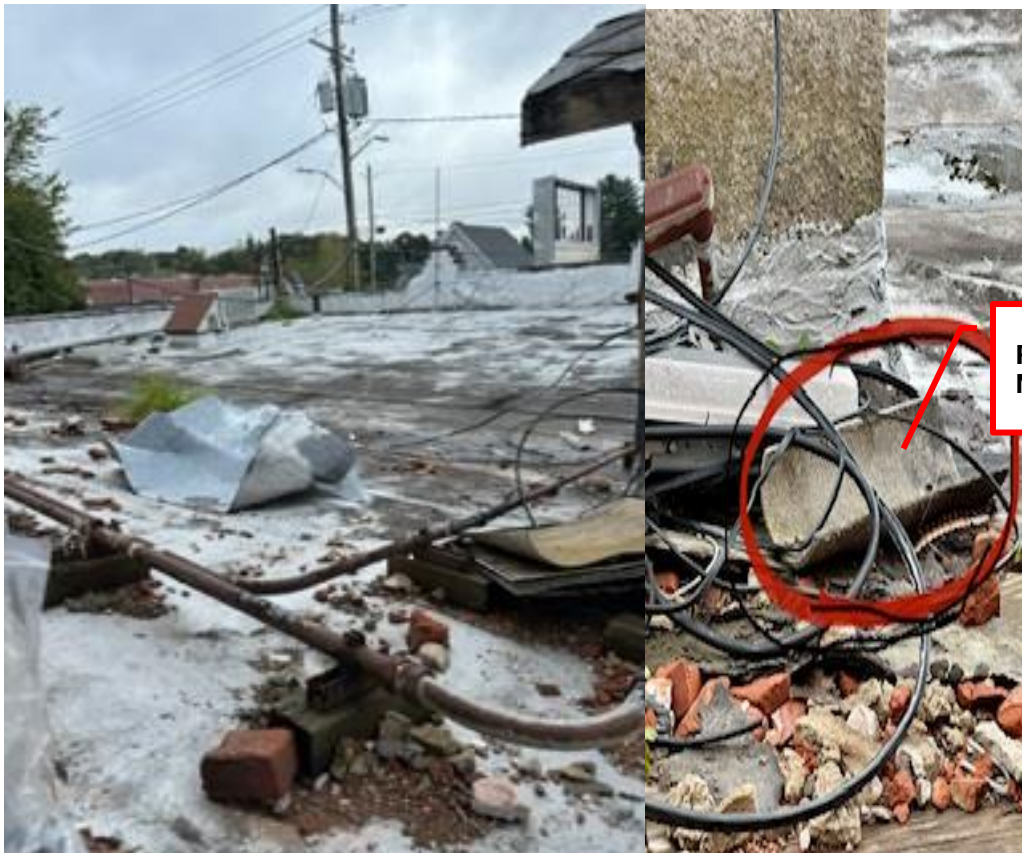
**ROOF
MATERIAL**

LOBBY ROOF (LEFT) & FRONT ENTRY ROOF (RIGHT)

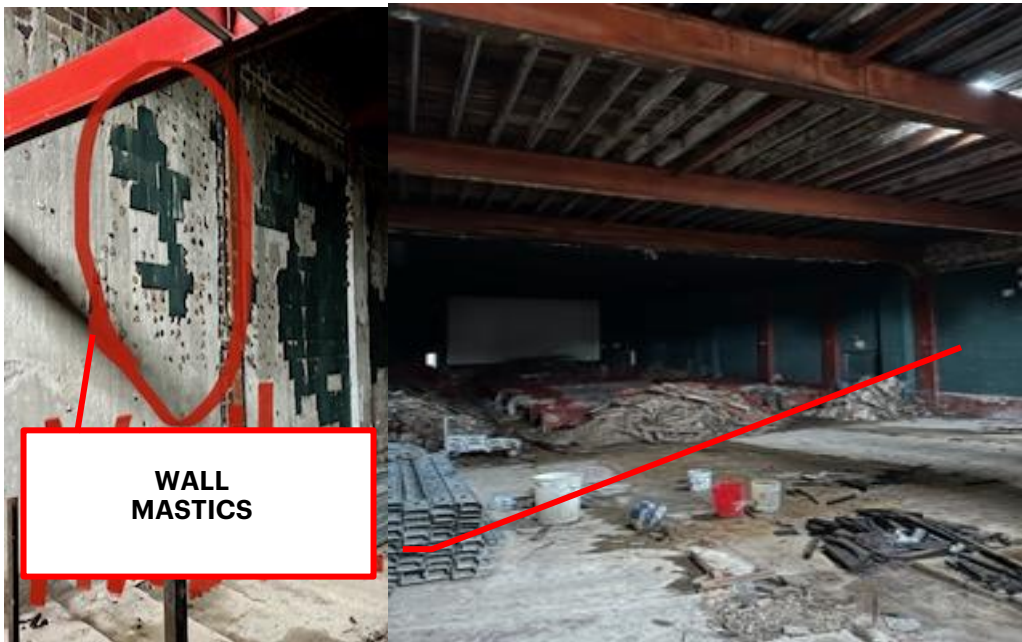
Material	Sample Location	Approximate Quantity Observed*	Figure ID #	% ACM & Type	Description / Locations / Friability
Mastic to Wall Sound Tiles	1 st Floor, Theatre Walls	± 1,200 ft ²	6-10	5.0% Chrysotile	The mastic to the soundproofing wall tiles was observed to be located beneath the tiles of the first-floor walls within the theatre building. This material was observed to be in black and yellow in color, in poor condition and is non-friable. While the associated wall tiles were not deemed positive, they should be treated as ACM due to their intimate association with the confirmed positive mastic.
Black Roofing	2 nd Floor, Front Lobby Roof	± 2,500 ft ²	27,28	3.9% Chrysotile	The front lobby roofing located above the second floor was observed to be in poor condition and is non-friable.
Black Roofing Mastic/Flashing	2 nd Floor, Front Lobby Roof	Up to ± 490 linear feet	29,30	3.9% Chrysotile	The grey-black flashing tar appears to be sporadically used on the roof along the edges, including the edge between the upper and lower roof sections. This material was observed to be in good condition and is non-friable.

THEATRE, WALL MASTIC SIDE WALLS

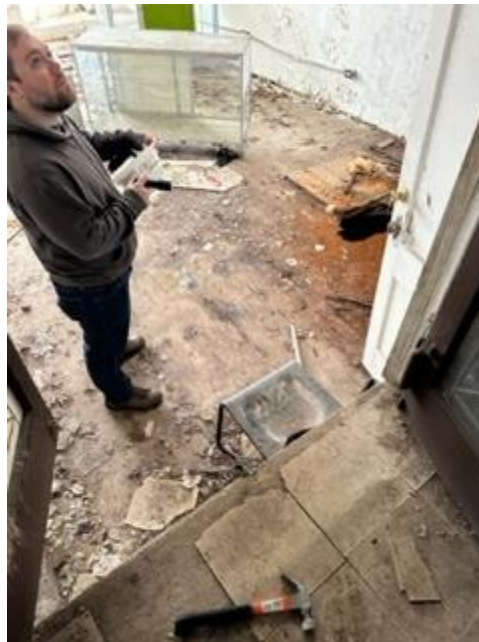
FRONT CONCESSION TILES

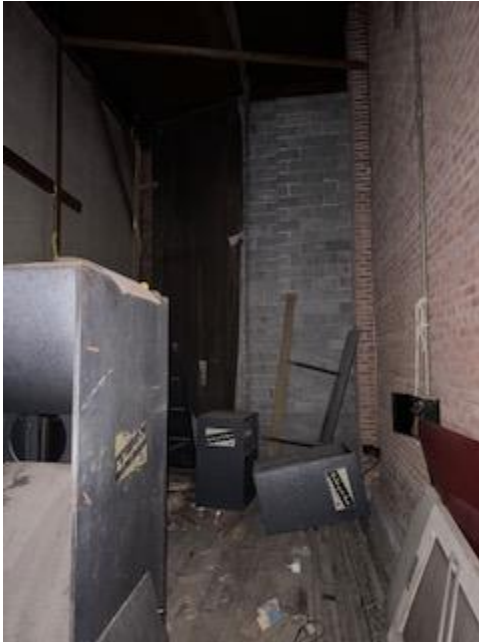
REAR STAGE AREAS

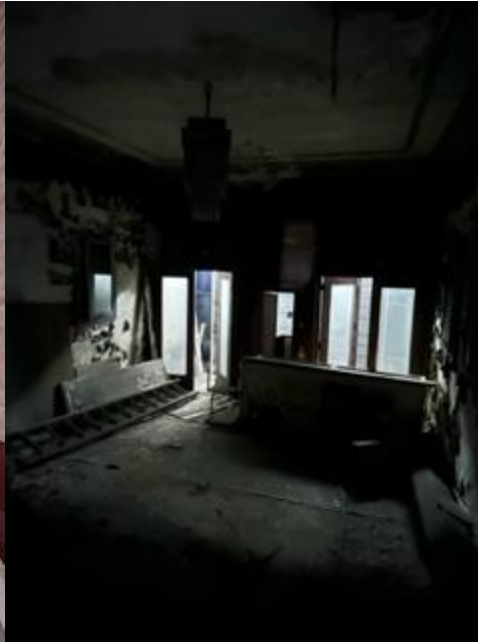
Samples of suspect paint were observed, sampled, and submitted for laboratory analysis. The front entry lobby and the entry molding paint were reported as > 0.5% lead (Positive) while the samples of paint from interior walls were < 0.5% lead (Negative).

FRONT LOBBY

Based upon the findings, the impact to lead containing surfaces can be handled during construction work, however these materials should not be sanded, burned, or heated to avoid creating vapor/airborne dust particles. TCLP testing is recommended for disposal characterization.
