**Request for Proposals to
Purchase & Redevelop
91 Chestnut Street
Liberty, NY 12754**

Date Issued: Friday October 7, 2022

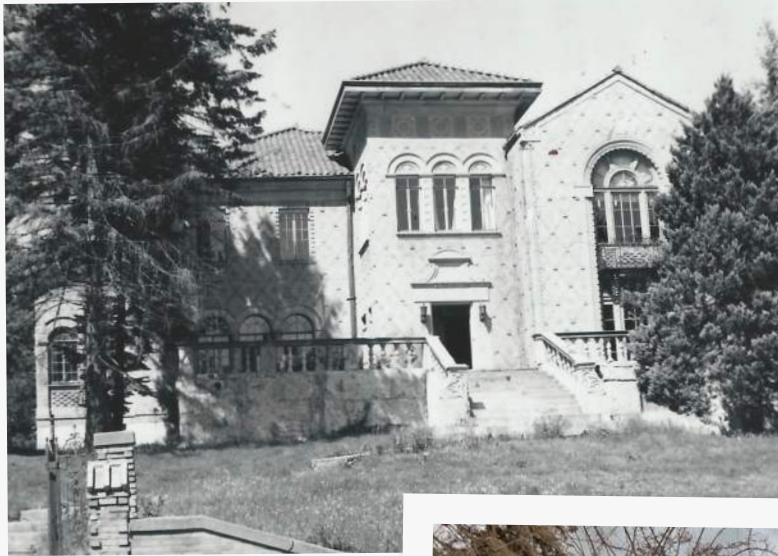
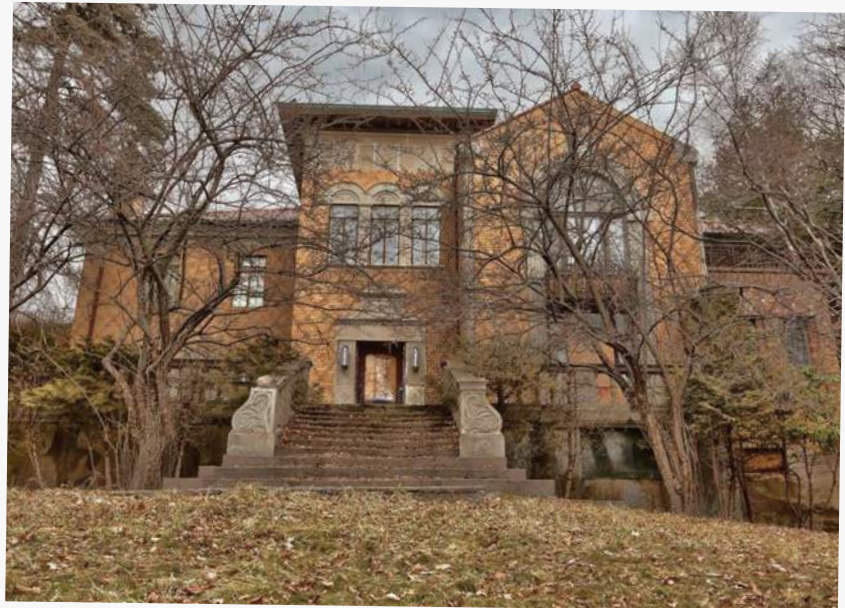
91 CHESTNUT STREET, LIBERTY, NY 12754

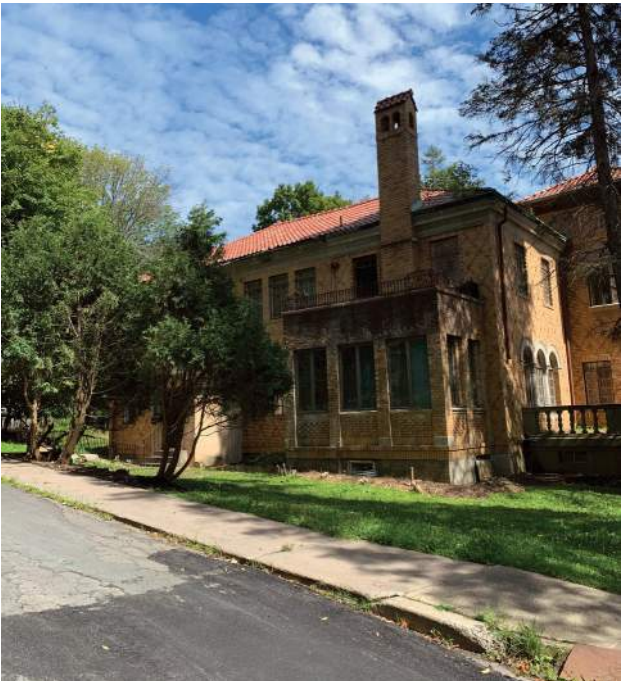
Property West from Hadden Road

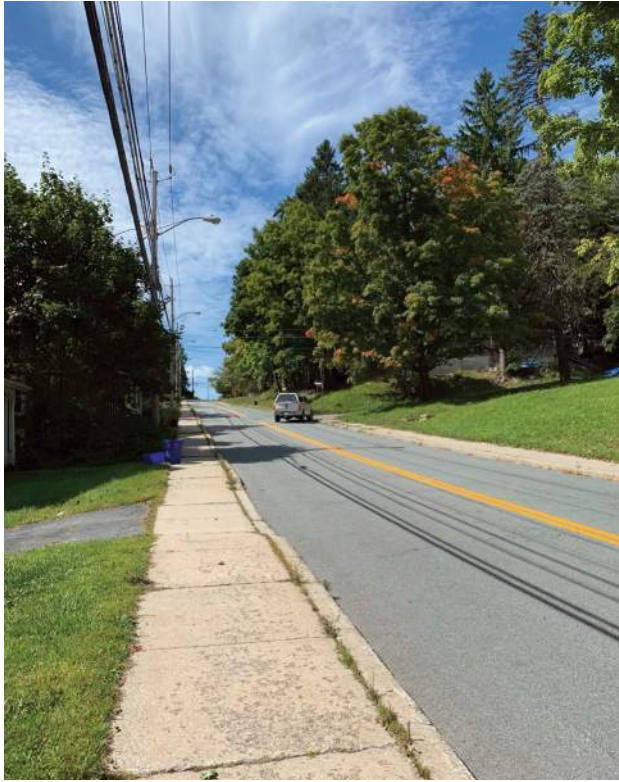
West Chestnut Street

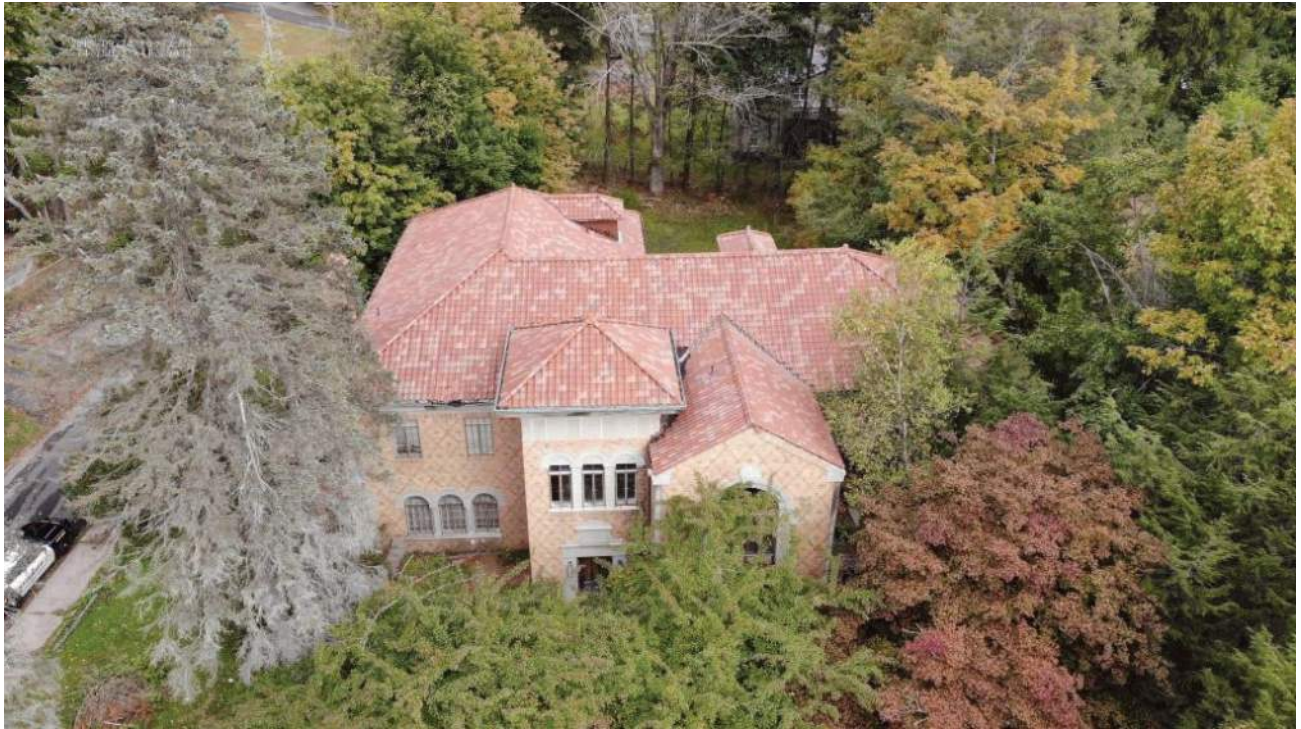
Drone Photograph - Main Building Roof Mostly Intact

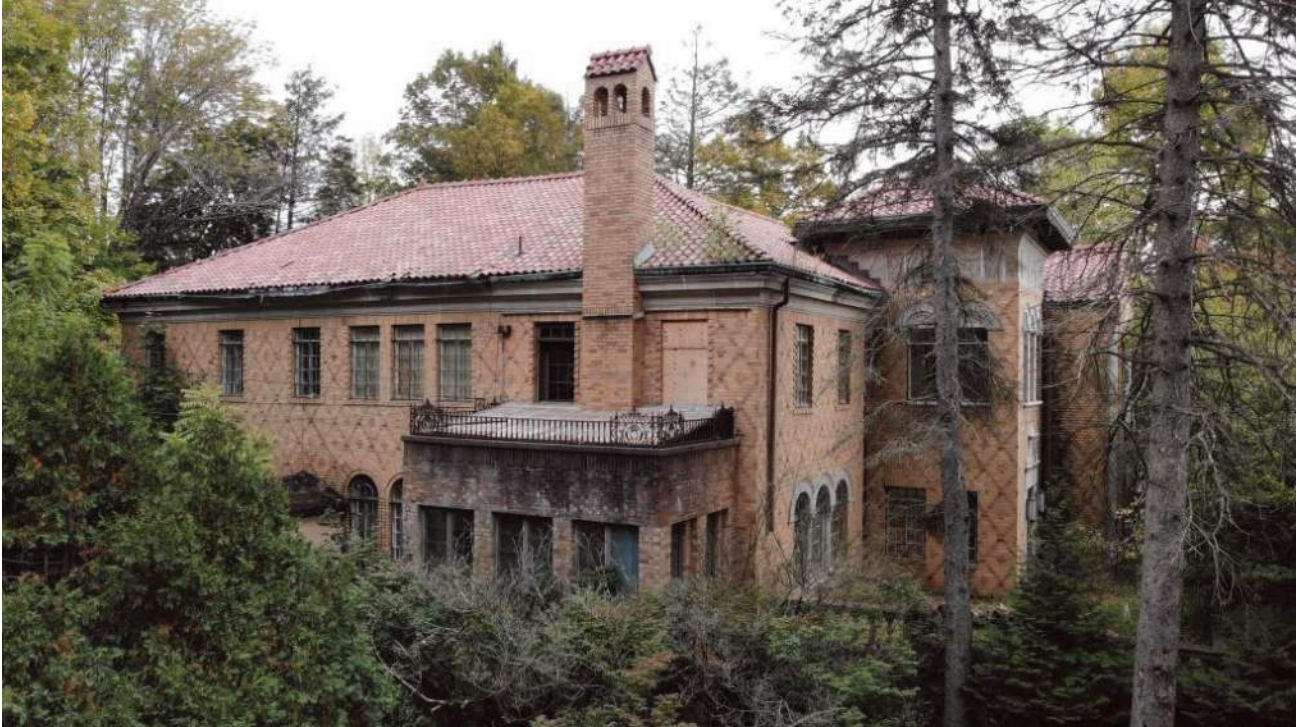
Drone Photograph - Temporary Roof over West Porch and Collapsing Gutter System and Incomplete Downspout System

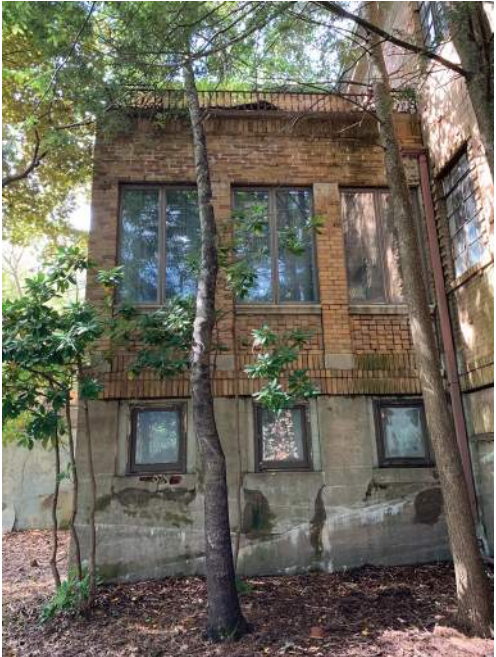
Southeast sunporch with temporary roof above – refer to first floor interior images, first floor windows are a modern enclosure of the porches typical

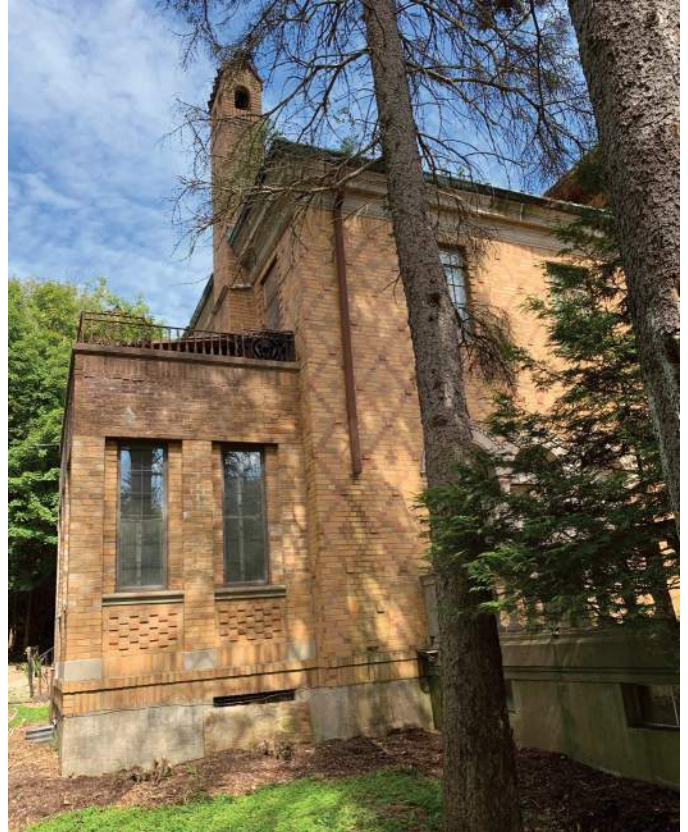
Temporary Roof over West Porch and Incomplete Downspout System

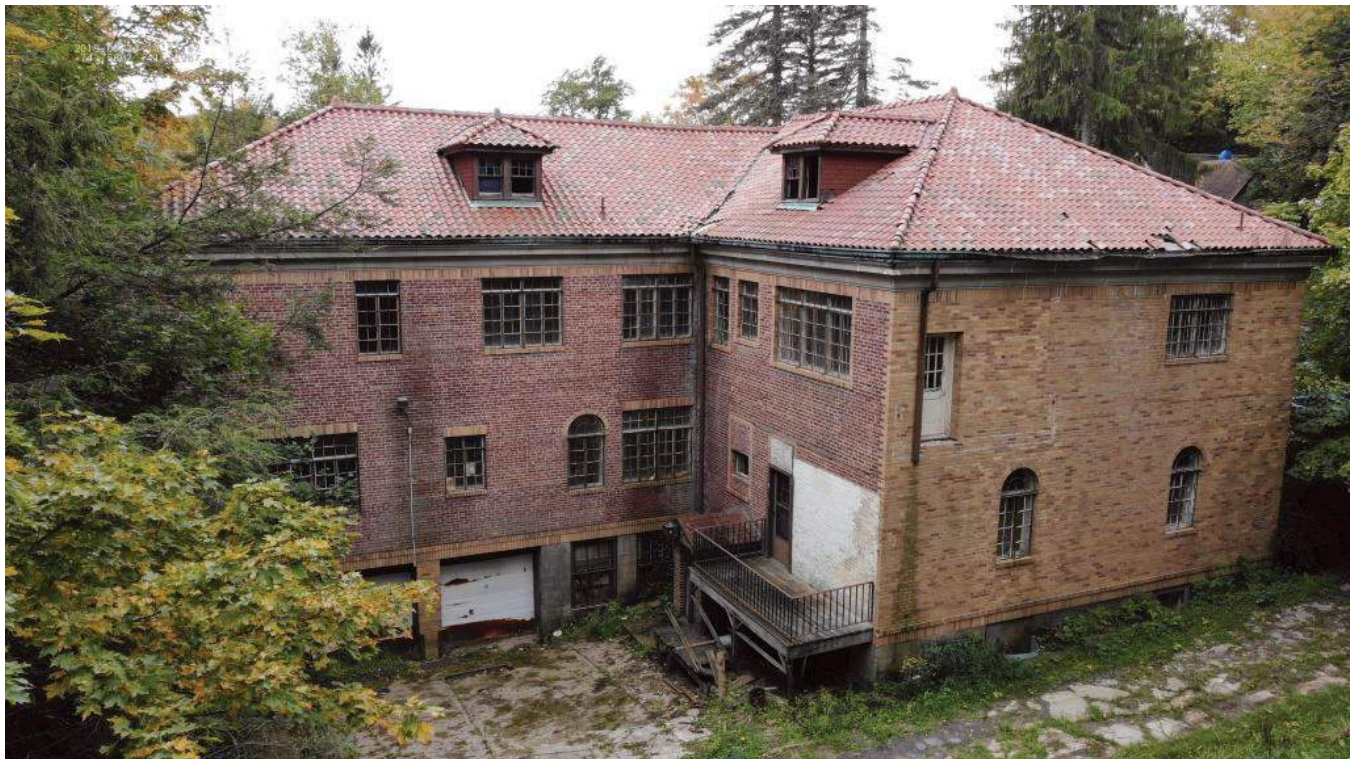
Drone Photograph - Main Building North, Roof Mostly Intact and Collapsing Gutter System and Incomplete Downspout System

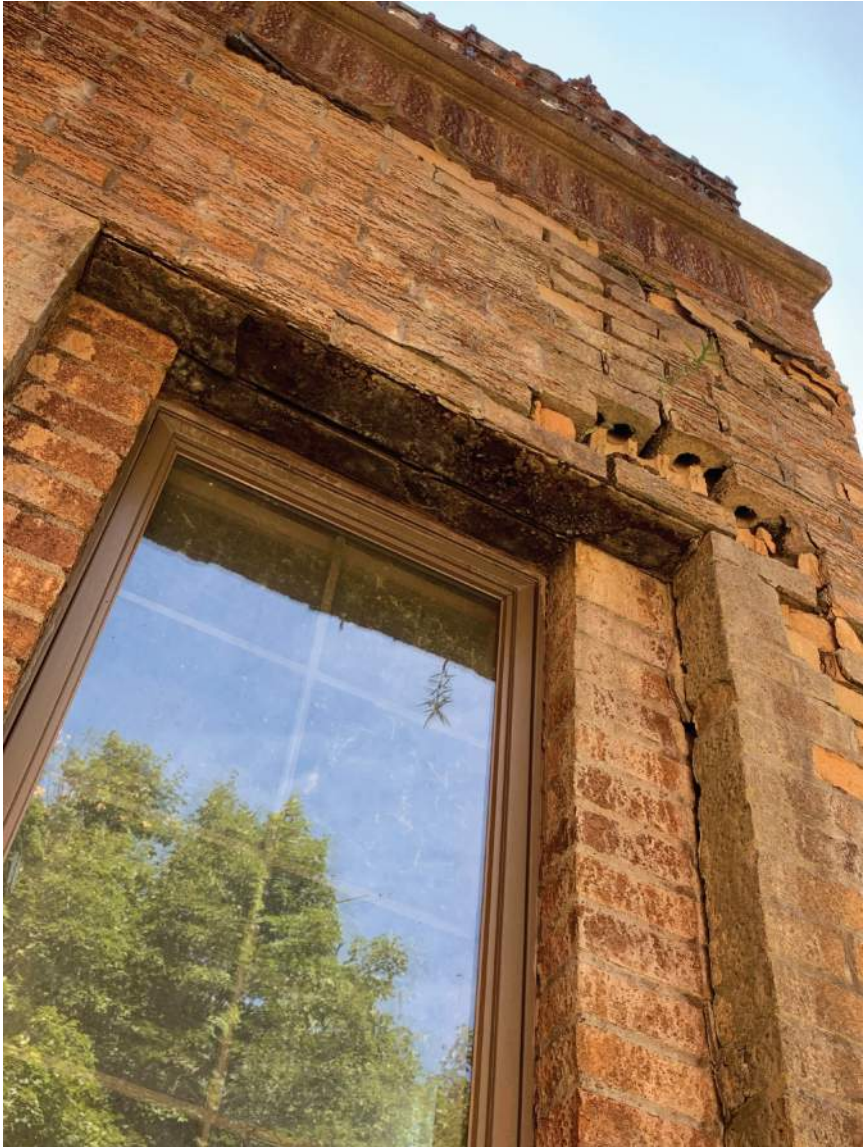
Brick Repair Required at West Sunporch Typical

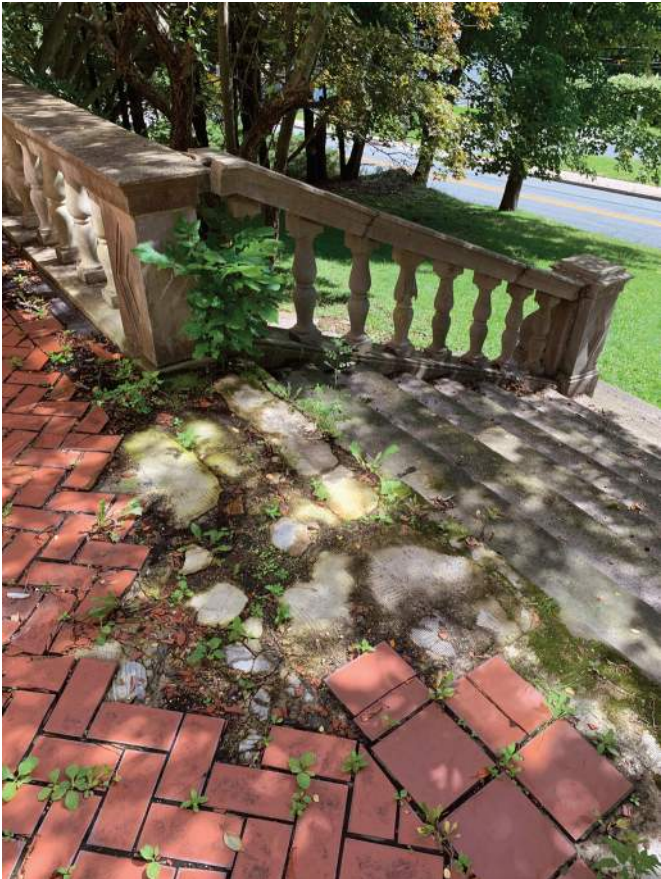
Concrete Stair up to Terrace and Main (Front) Building Entrance off of Chestnut Street

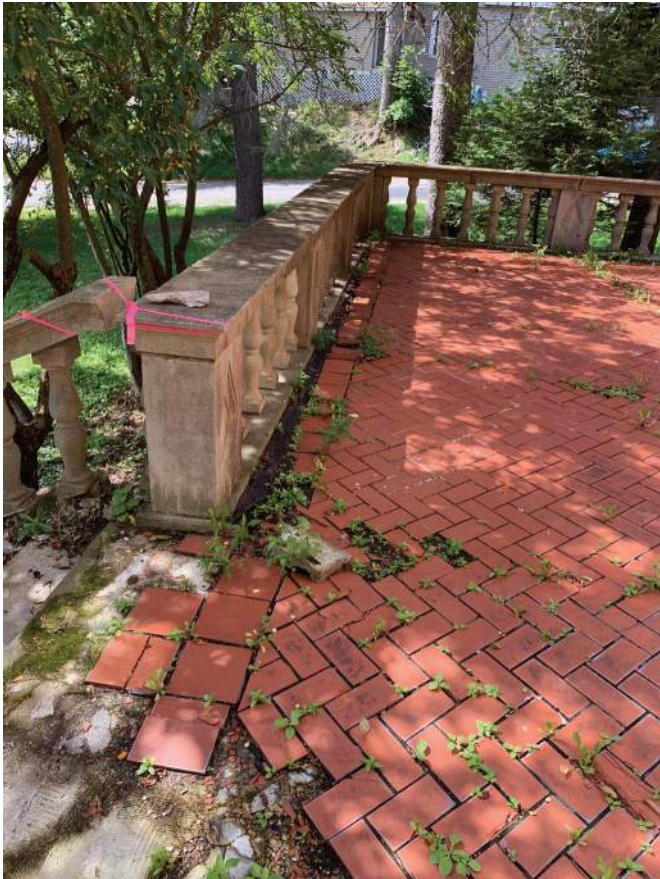
Southwest Corner of Terrace and Stair

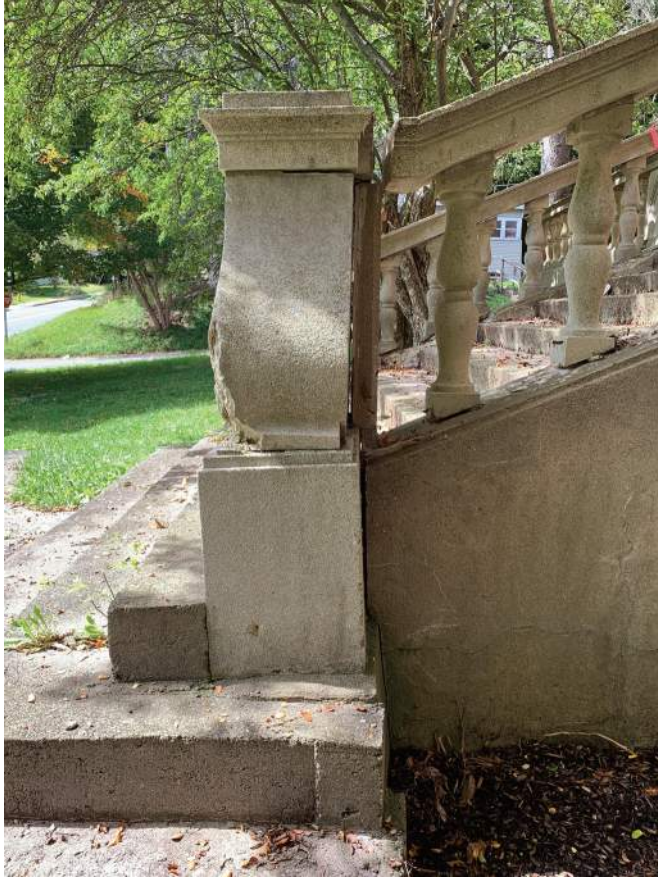
Deteriorating Cast Stone Terrace Stair Site Elements

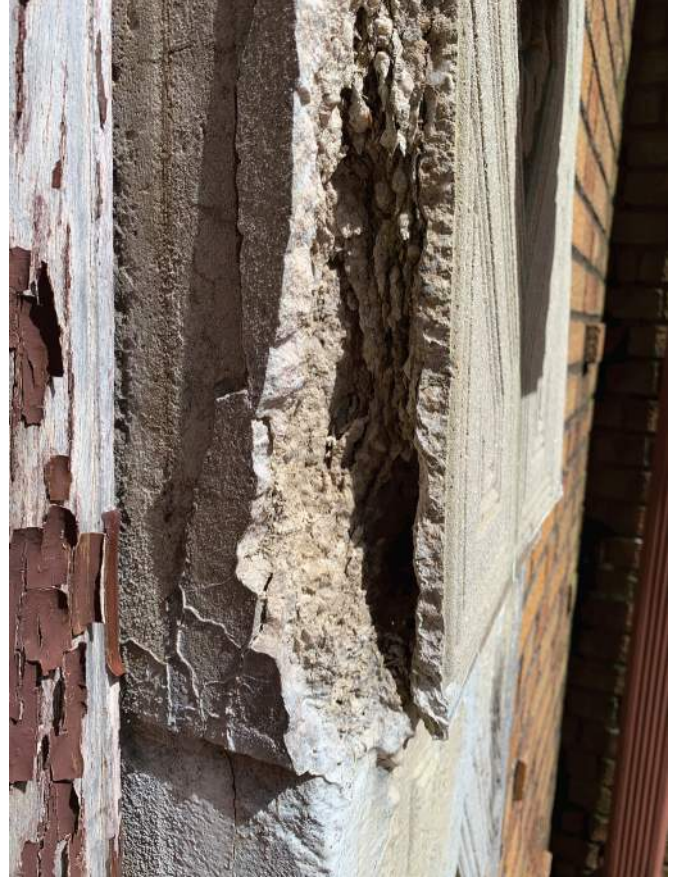
Deteriorating Cast Stone Building Element at Door with Signs of Past Repair

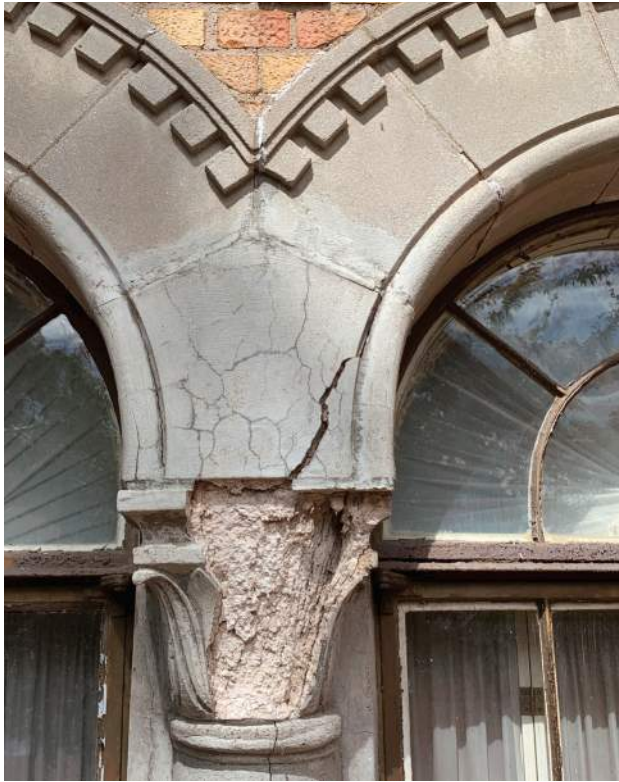
Deteriorating Cast Stone Building Element - Showing Signs of Repair at Window Hood Pilaster

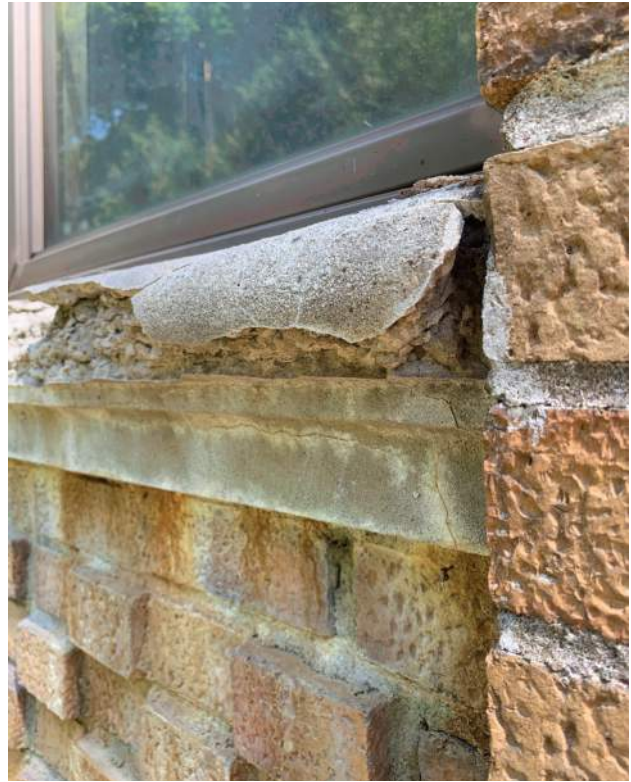
Deteriorating Cast Stone Building Element at Sunporch Sill

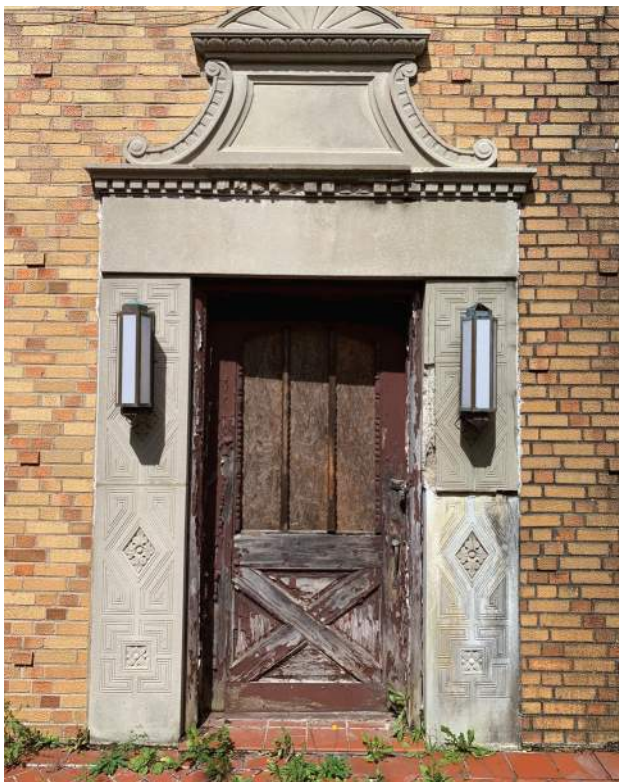
Main Entrance - Example of Cast Stone Repair and Cast Stone Replacement

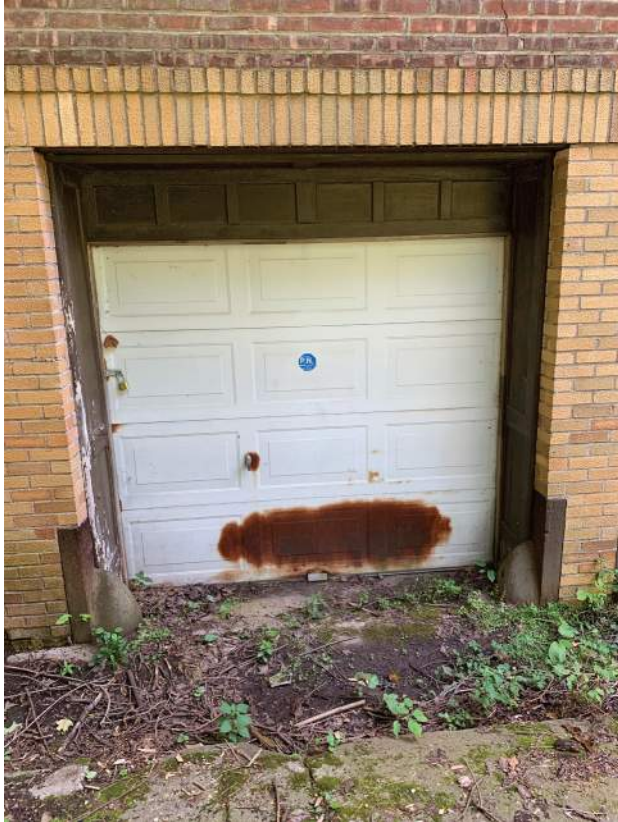
Basement Garage Door - Wood Surround

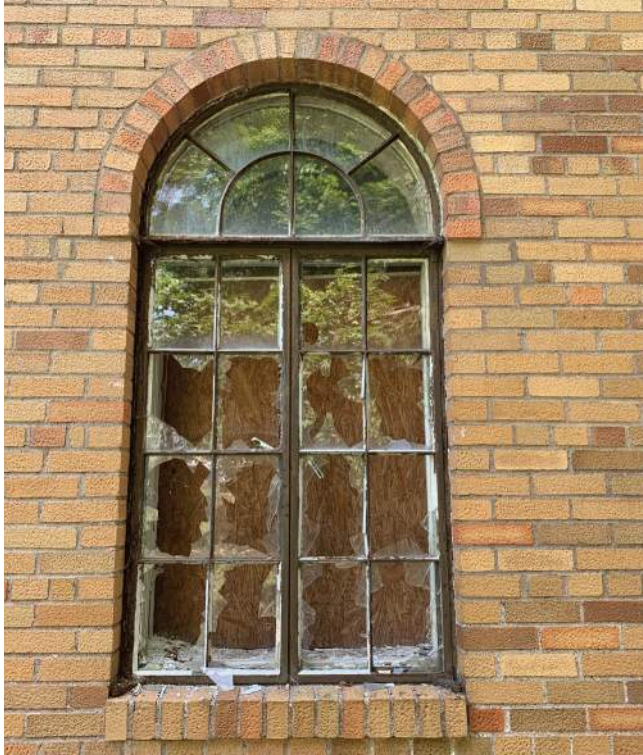
Typical Steel Casement Window with Half Round Top

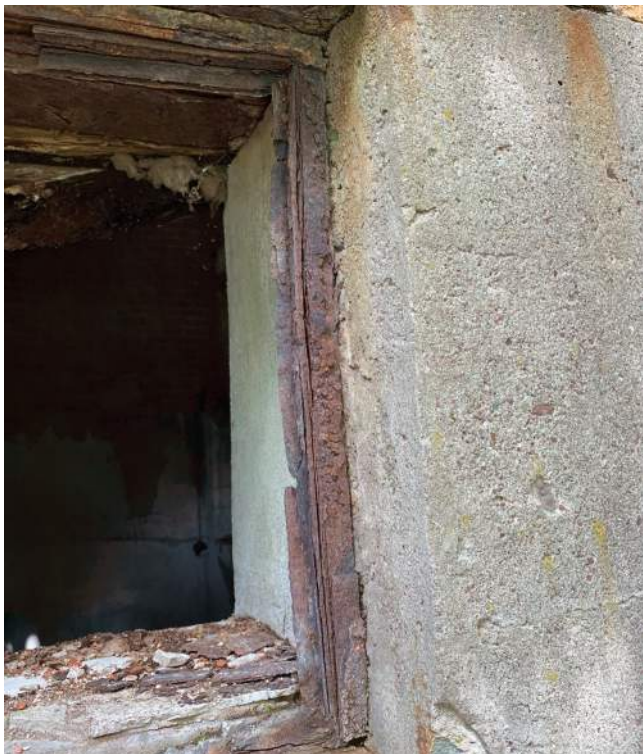
Basement Level Window Opening

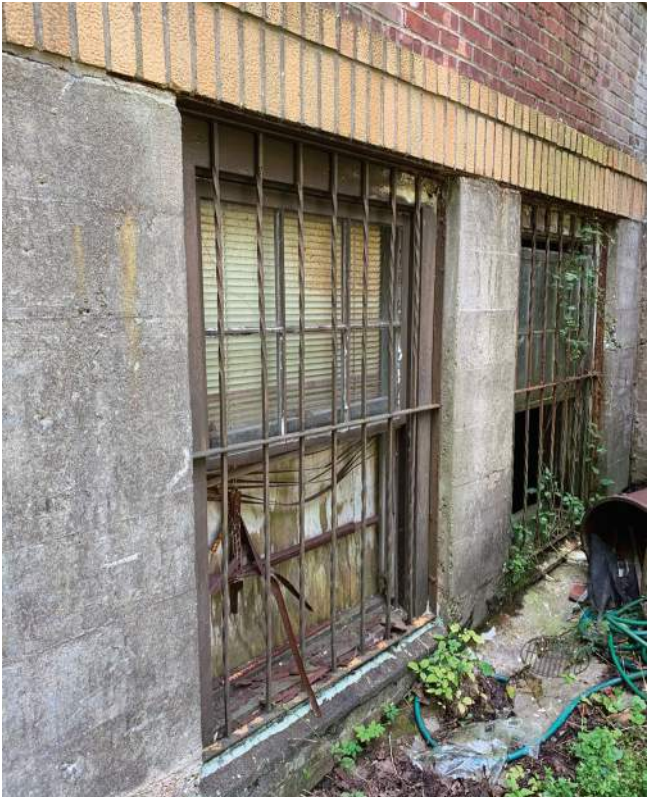
Basement Level Wood Windows

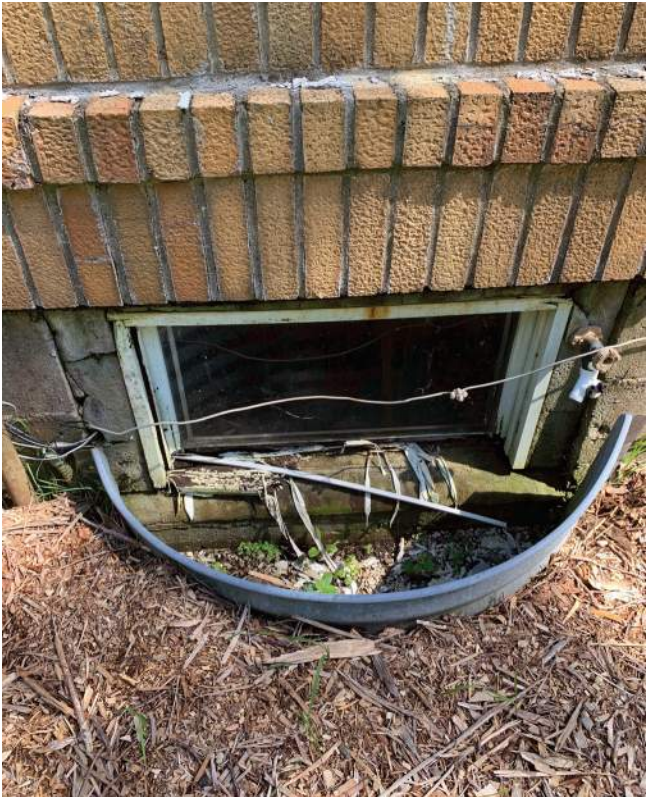
Example of Altered Basement Window Opening and Deteriorated Replacement Window

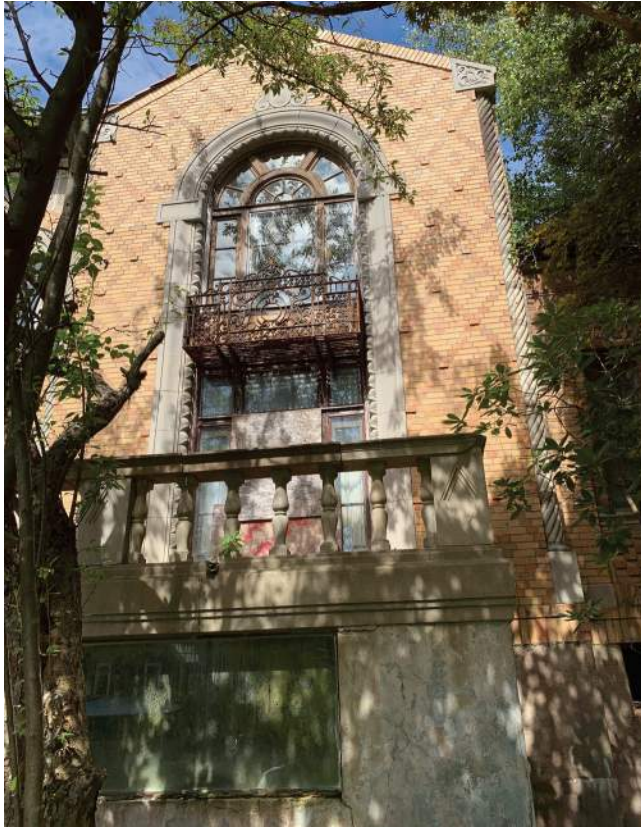
Existing Conditions - Exterior

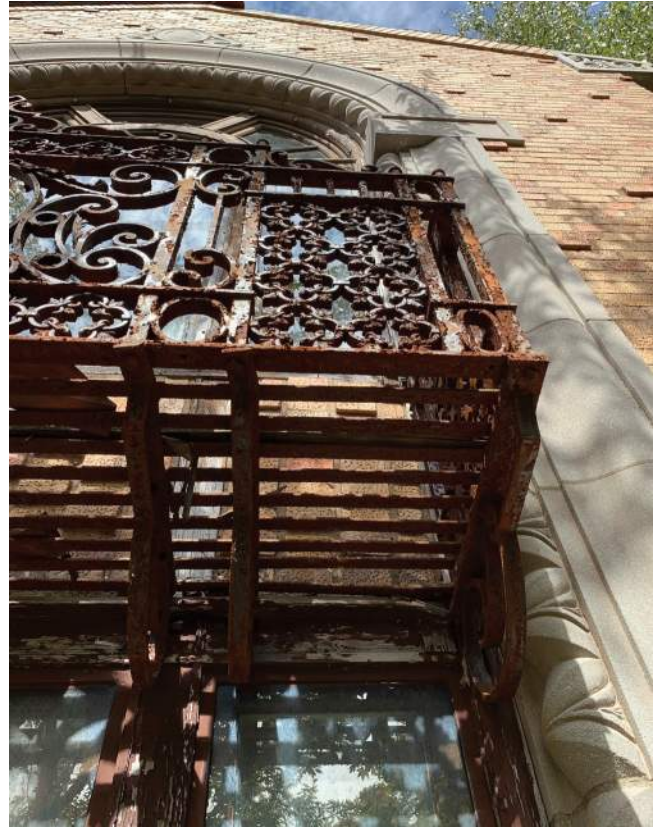
Second Level Wrought Iron Balcony

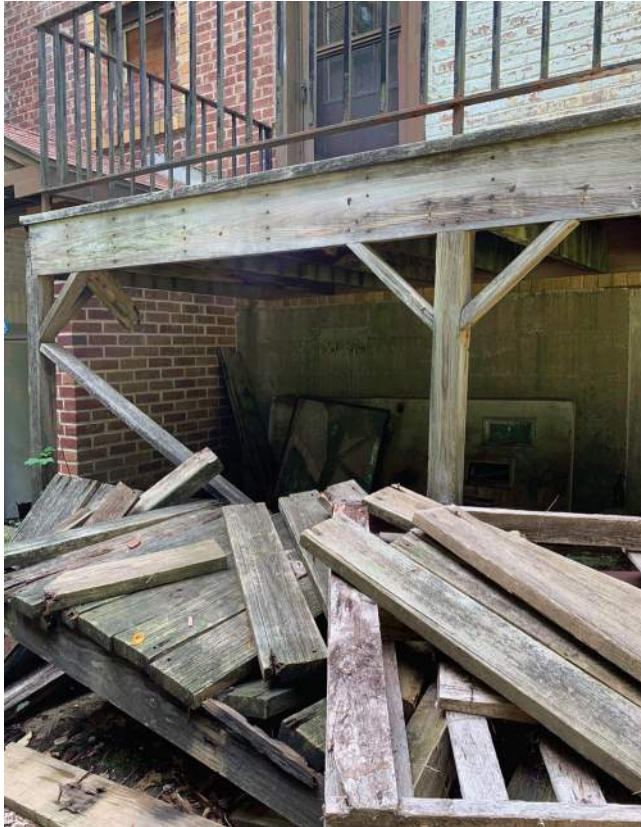
Wood Framed Platform on Rear of Building

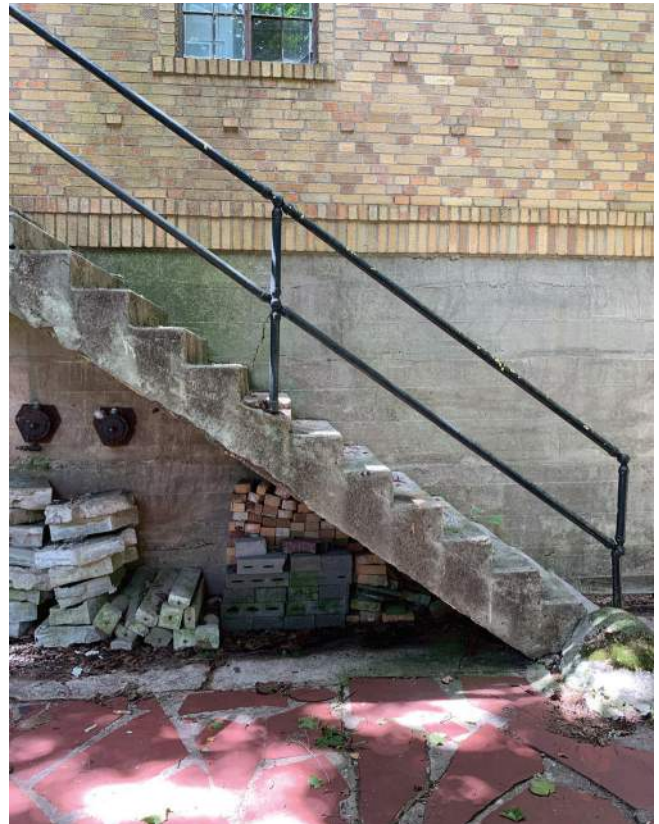
The building has undergone some changes of use and alterations. This wood framed platform may have been constructed when there was an attempt to turn the building into multiple apartments. At first glimpse, it should be removed. However it is placed on the 'rear' of the building, not in prominent view and may be suitably located to provide needed egress from the building or accessible access into the building, depending on the redevelopment plans that are to be realized.

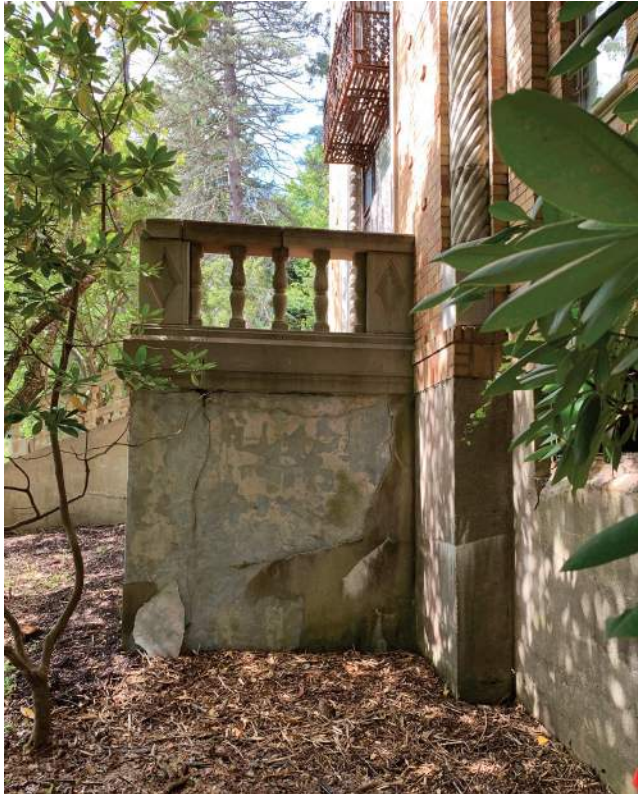
Area of the Terrace in need of Repair

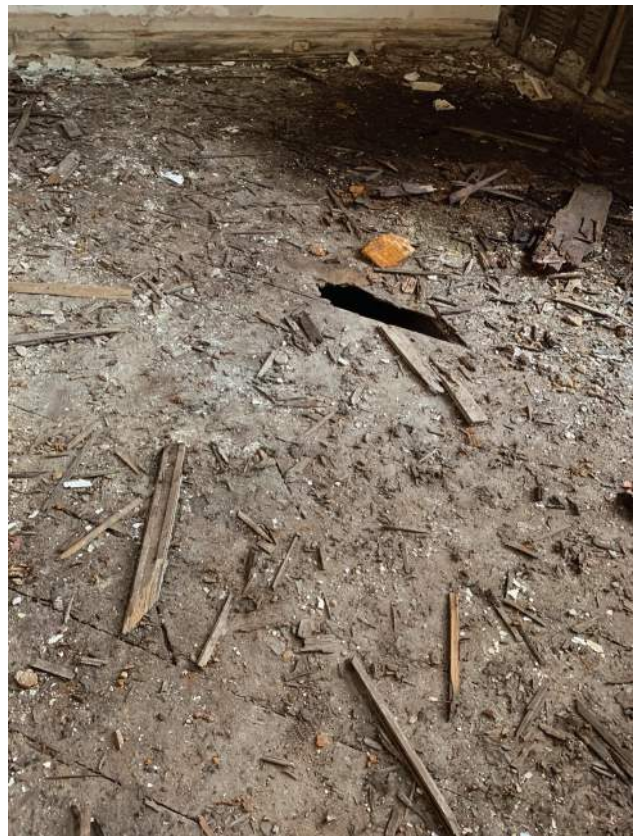
Water Damaged Wood Flooring

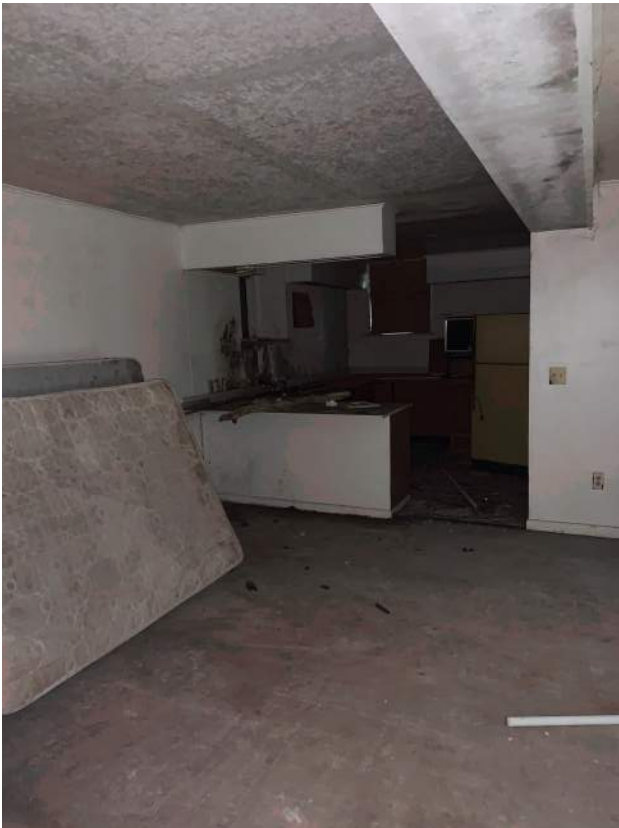
Apartment Kitchen with Window Boarded over

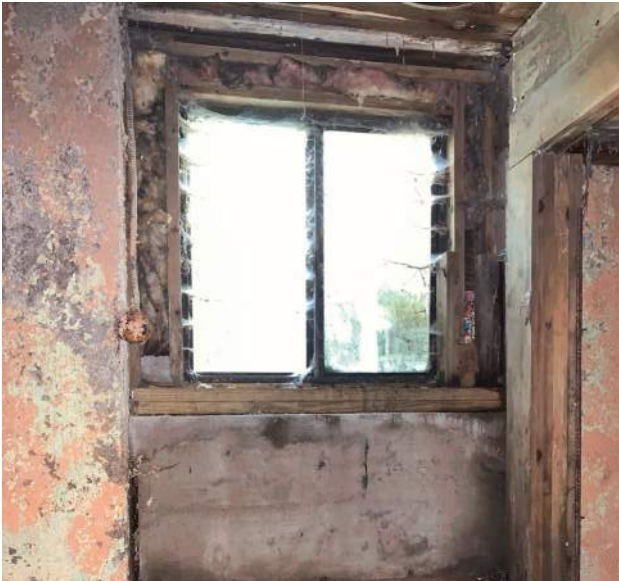
Original Lower Floor Level Window Opening Modified and Replaced

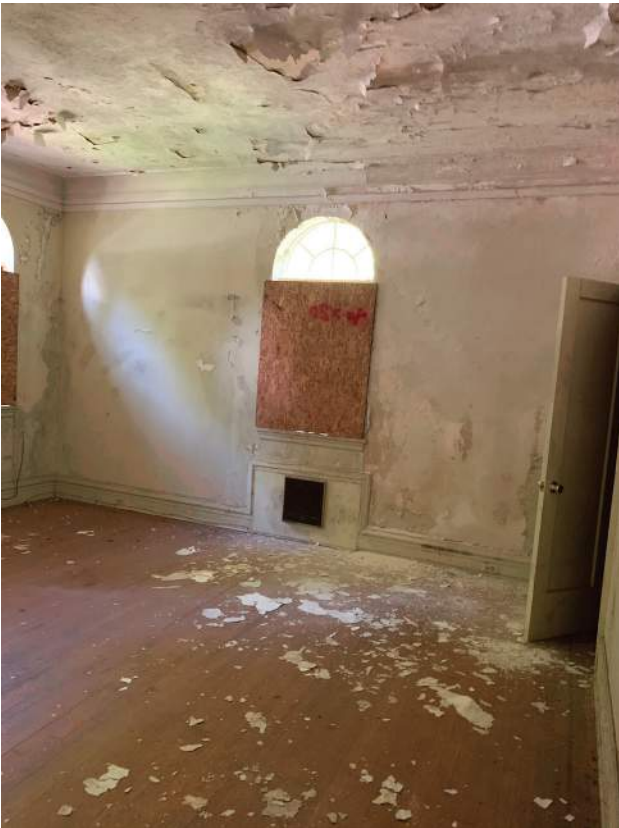
*Bedroom Above Apartment Living Area,
Northwest Corner of Building*

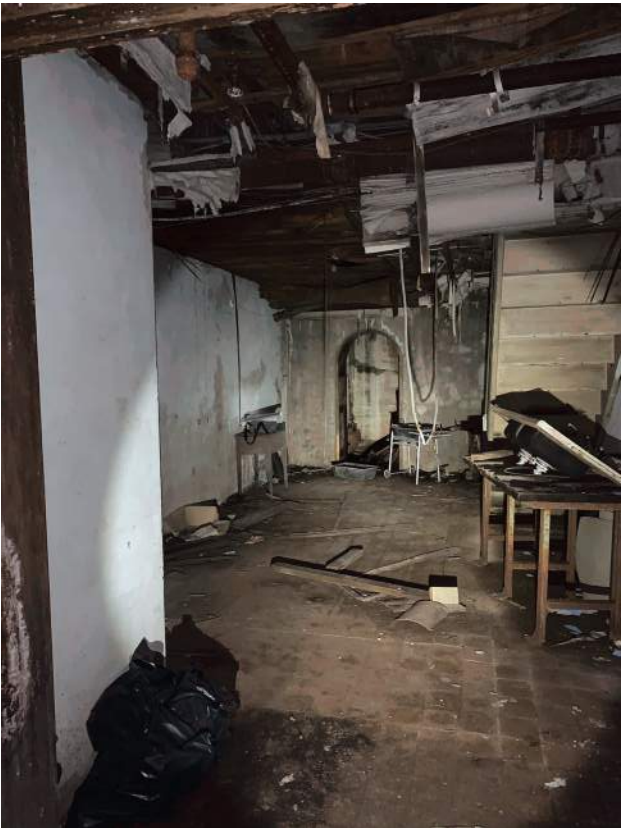
Lower Floor Level Lobby

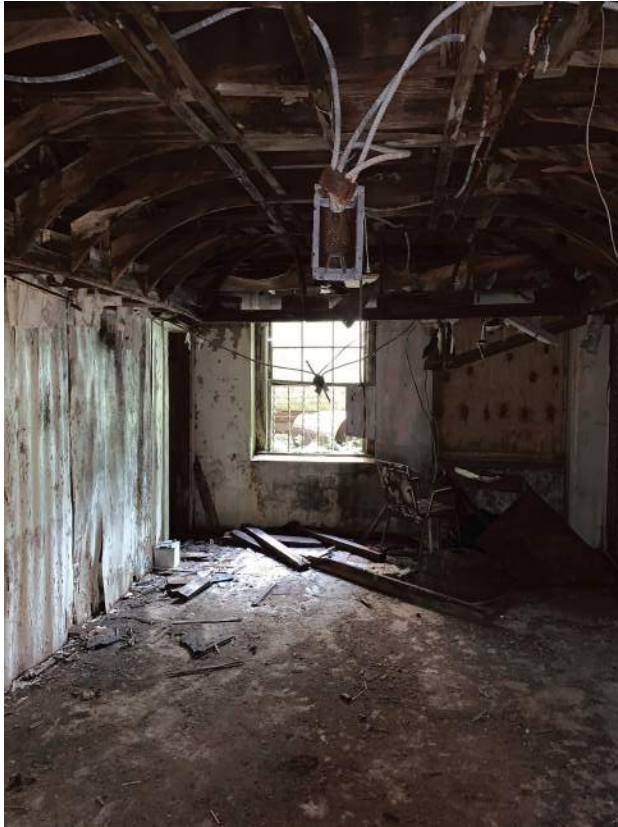
Laundry Room Showing Extensive Water Damage

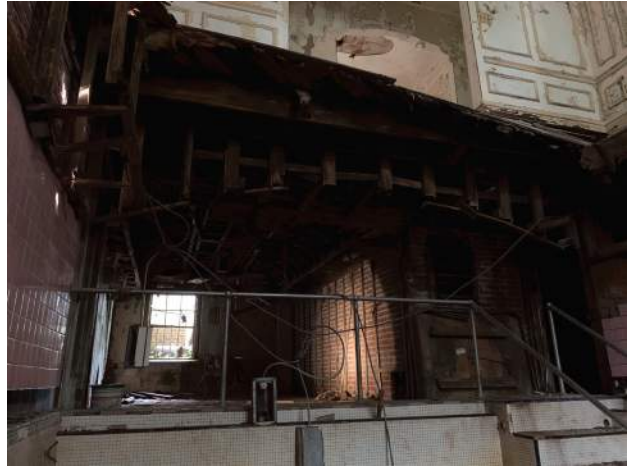
View From Pool (Billiard Room on Plans) with Laundry Room in Background and First Floor Level Above

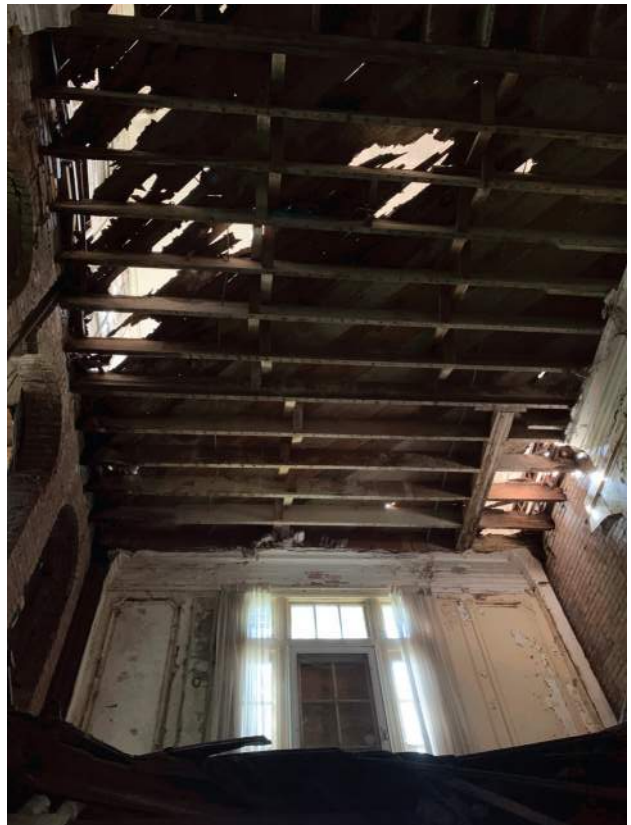
View From Pool (Billiards Room on Plans) to First Floor Living Room Above and 2 Story Entrance in Background

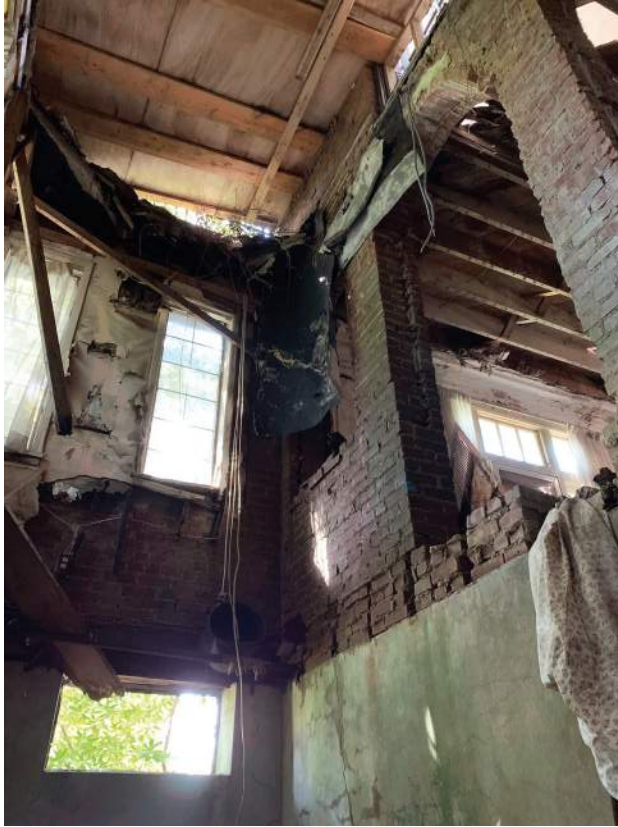
View From Lower Floor Level Beneath Southeast Sunporch and Temporary Roof Structure Located at Second Floor Level

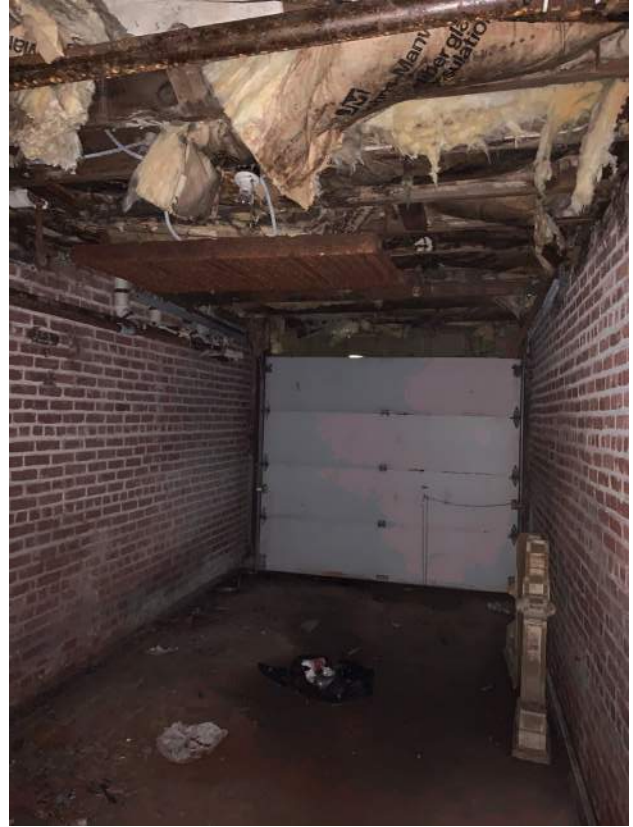
Typical Garage Condition

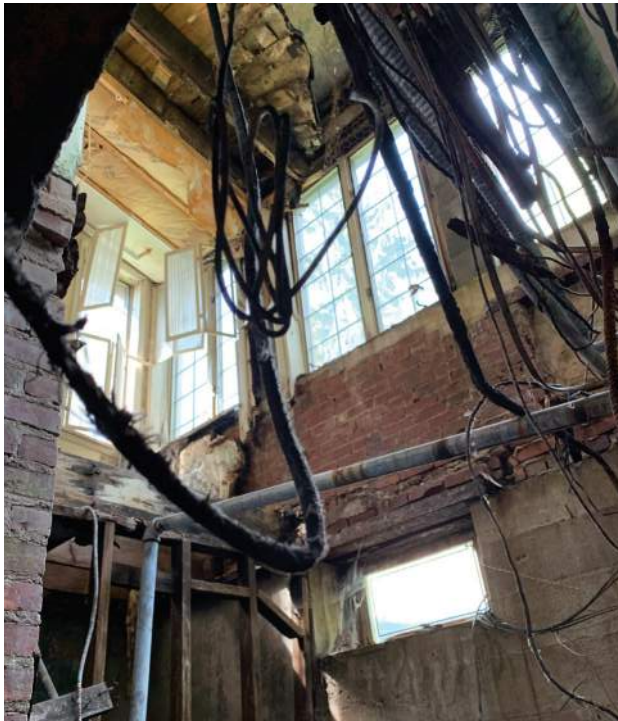
View From Lower Level Beneath West Sunporch and Temporary Roof Structure Located at Second Level

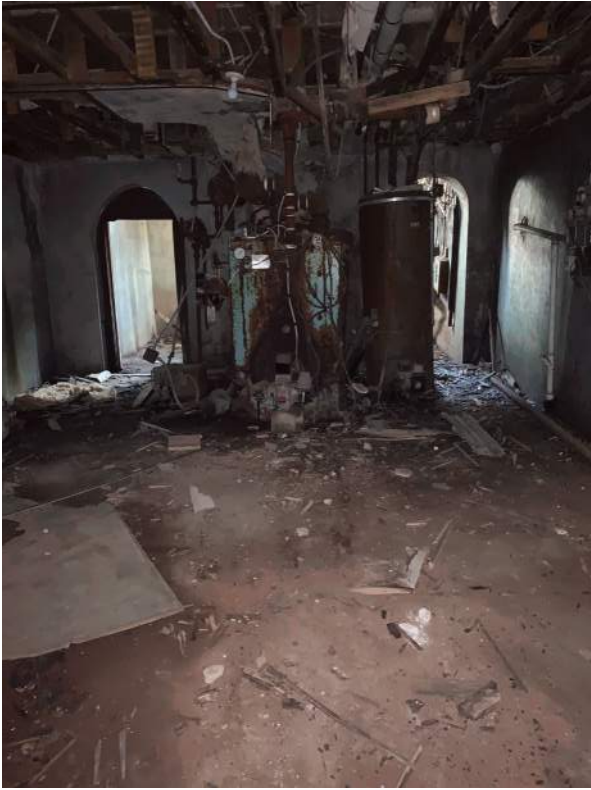
Central Boiler and Water Heater

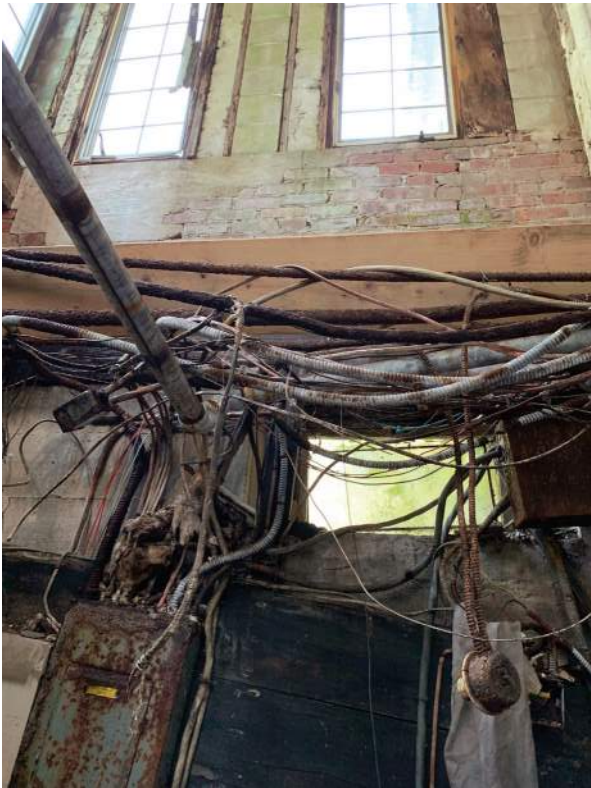
Main Electrical Service Distribution

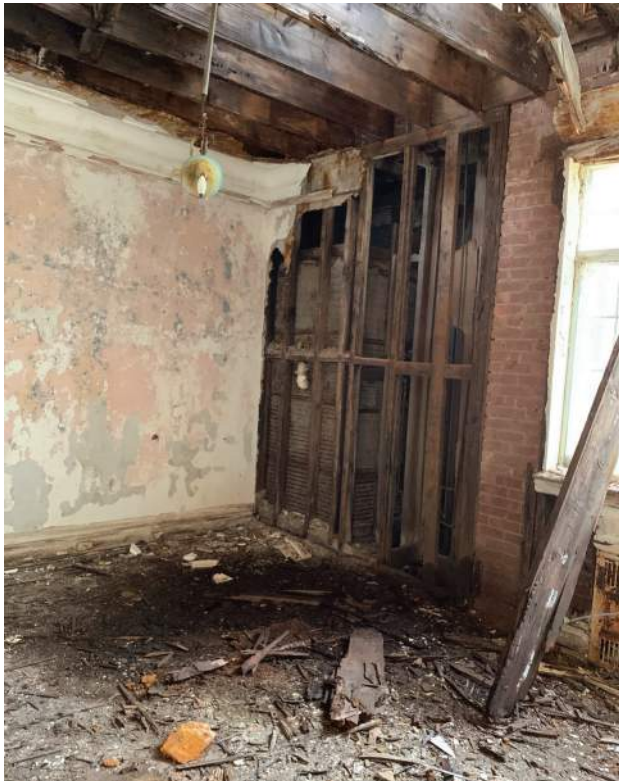
Bedroom with Water Damaged Floor and Collapsing Ceiling Joist Structure Above
