**Request for Proposals to
Purchase & Redevelop
91 Chestnut Street
Liberty, NY 12754**

Date Issued: Friday October 7, 2022

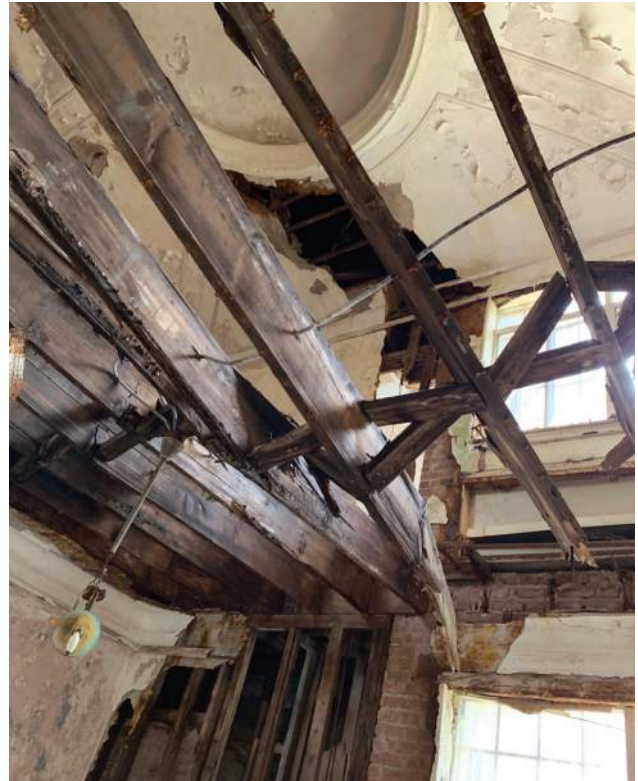
Domed Second Floor Level Reception Room Ceiling in the Background

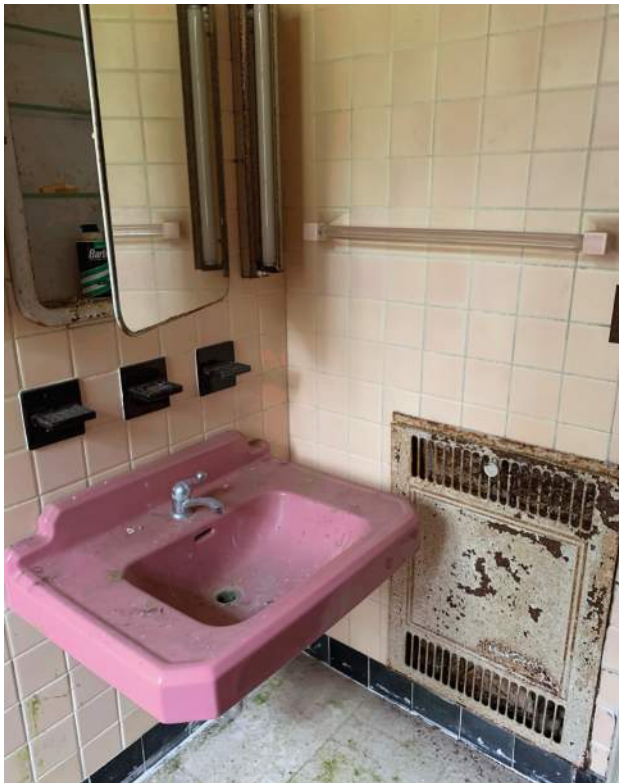
Sink Area of First Floor Level Bathroom

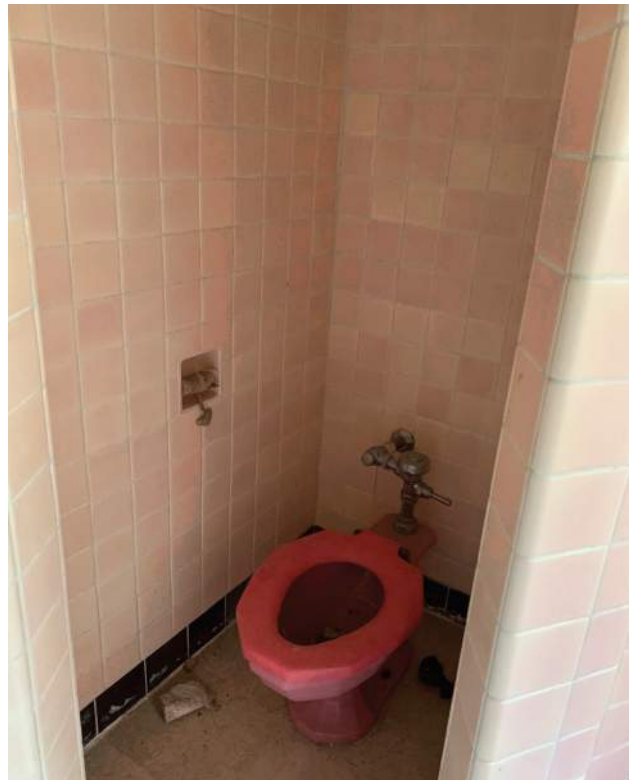
Toilet Area of First Floor Level Bathroom

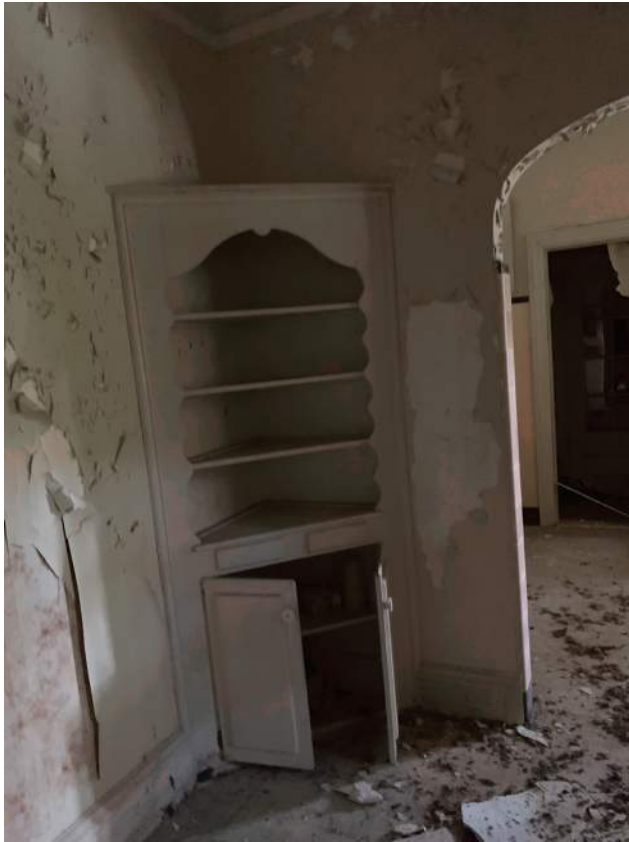
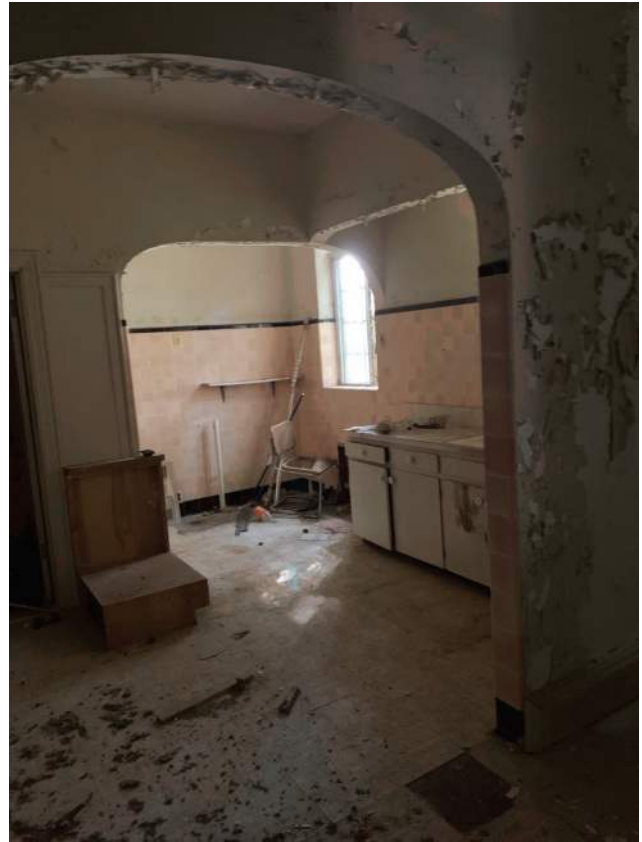
Existing Conditions - Interior, First Floor Level

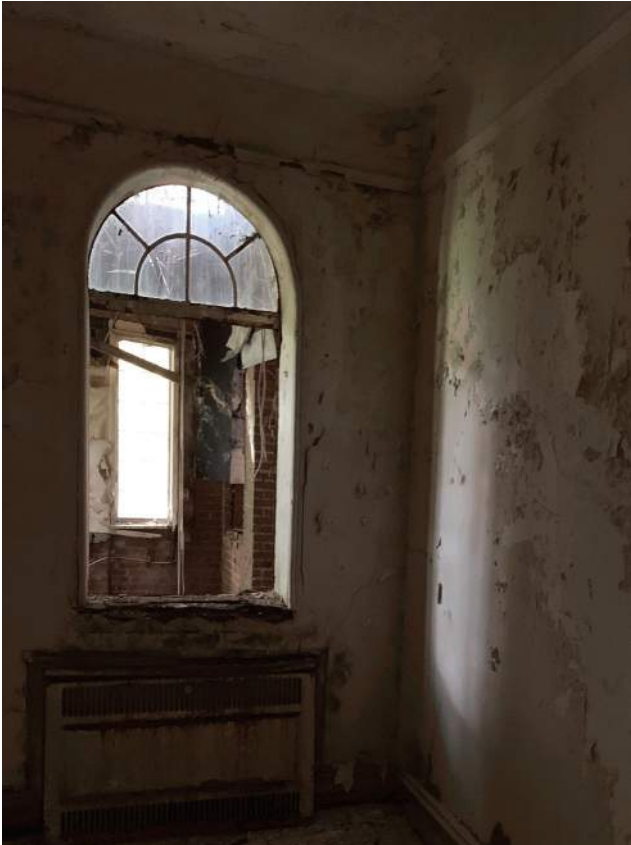
View from First Floor Level Kitchen into Southeast Sunporch

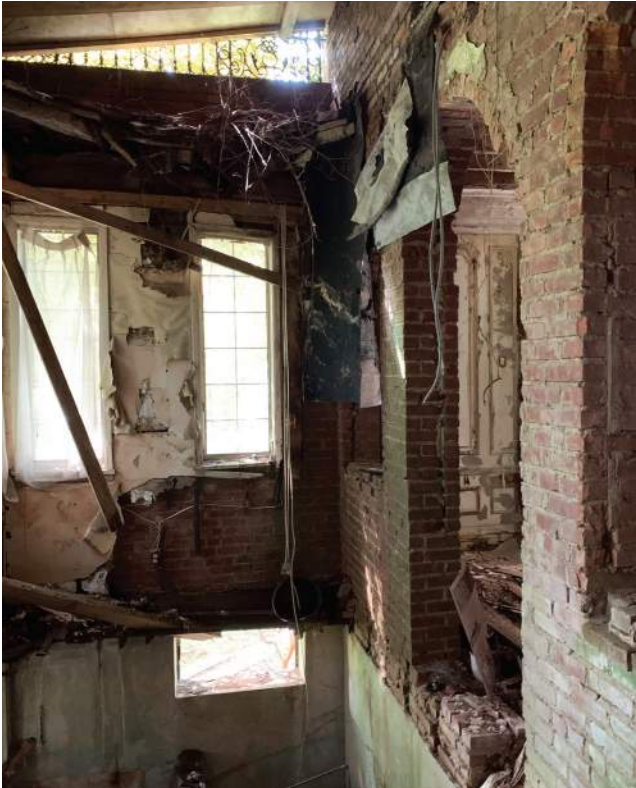
Existing Conditions - Interior, First Floor Level

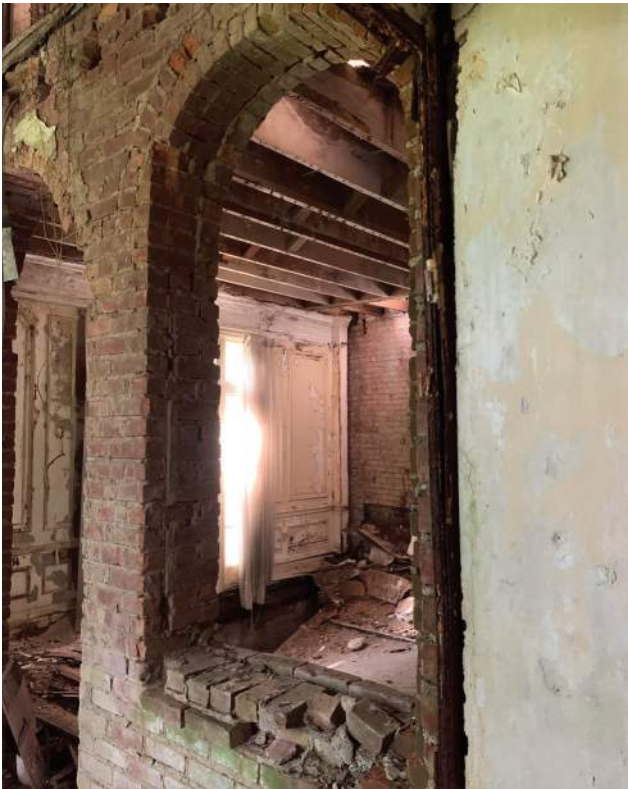
First Floor Level Living Room

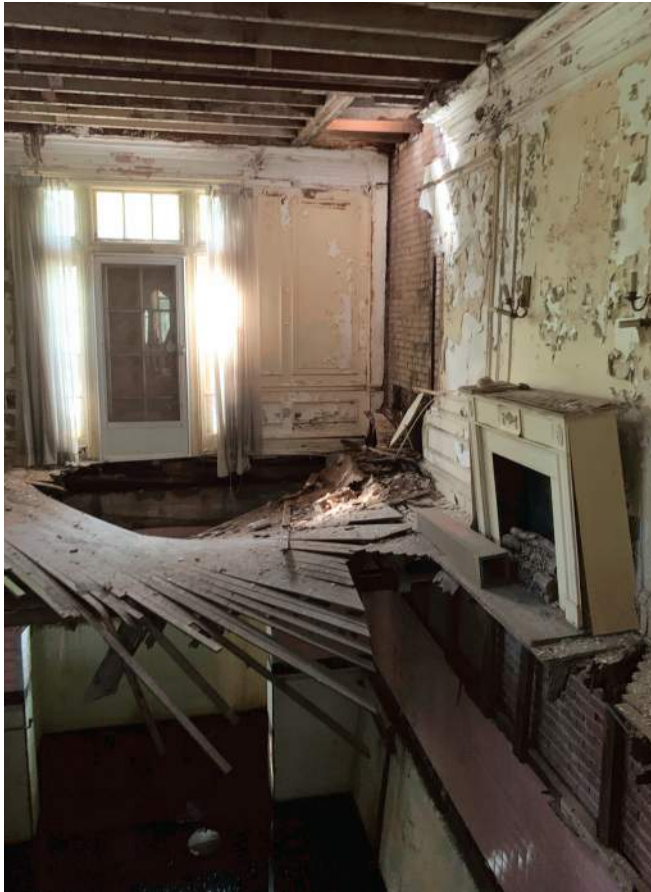
Living Room Floor and Exposed Brick at Southeast Corner

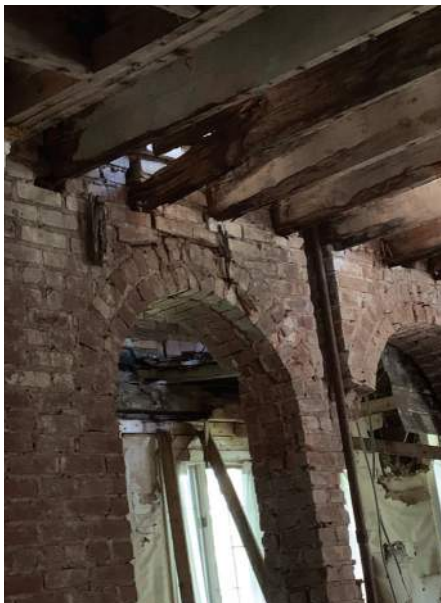
First Floor Level Living Room Ceiling Condition at Southeast Sunporch

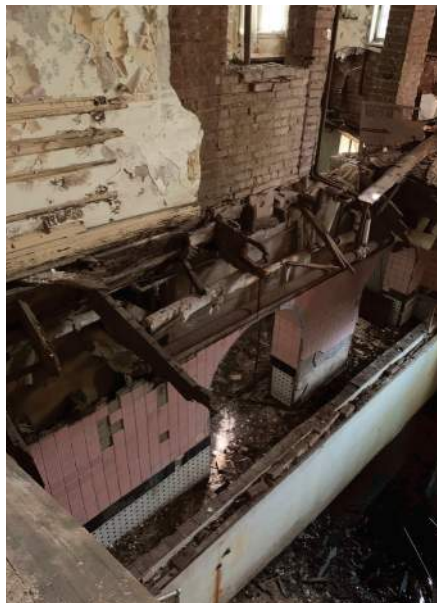
Looking into Pool and Pool Bath

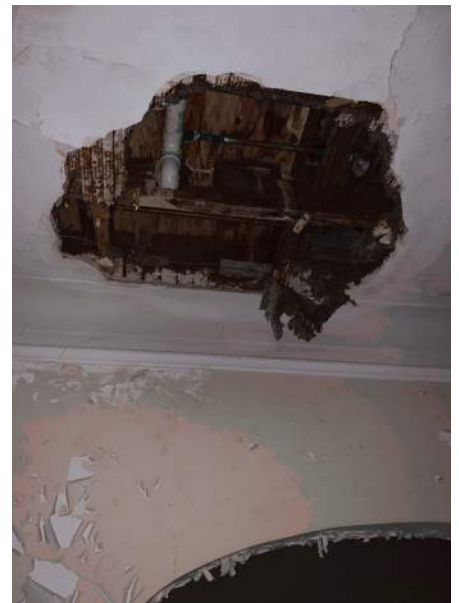
First Level Ceiling Evidence that Pipe Leaks Have Caused Damage

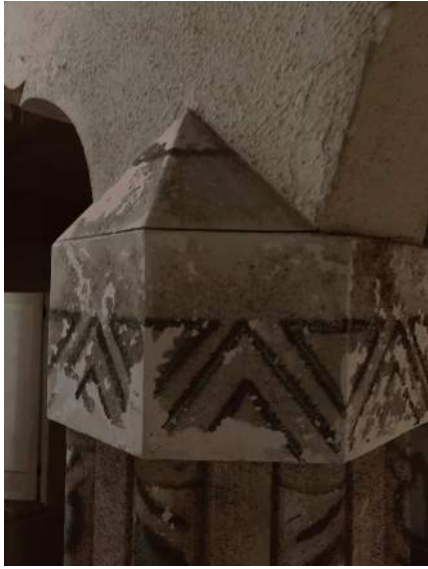
Decorative Column Cap

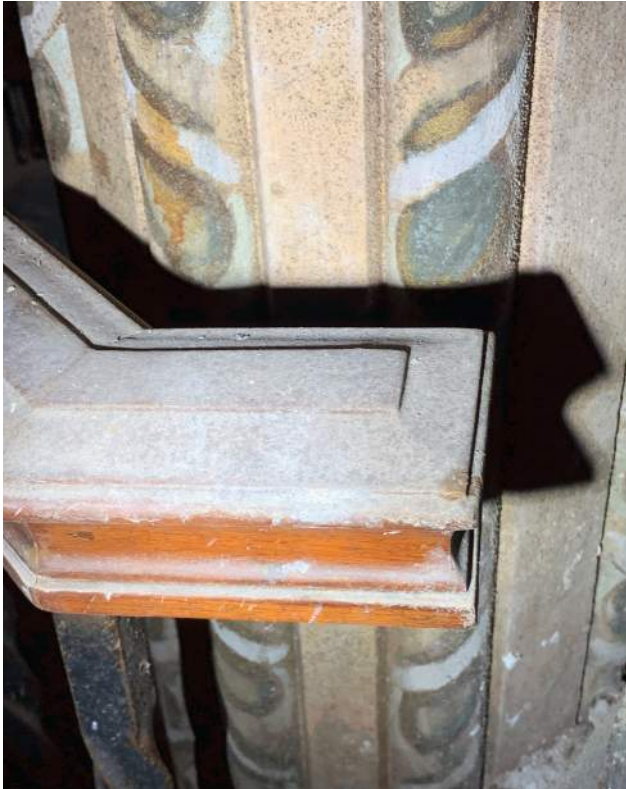
Lobby Stair Railing and Decorative Column

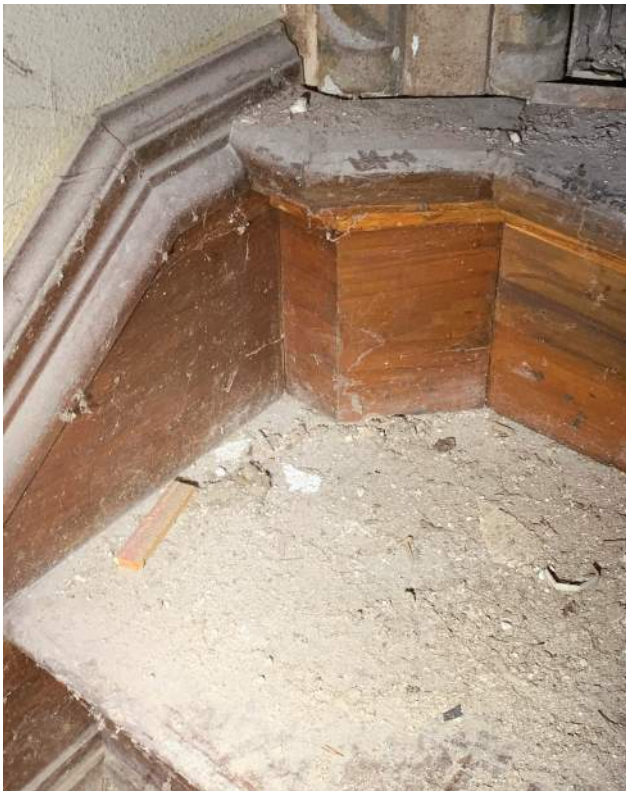
Lobby Stair Riser and Skirt Board

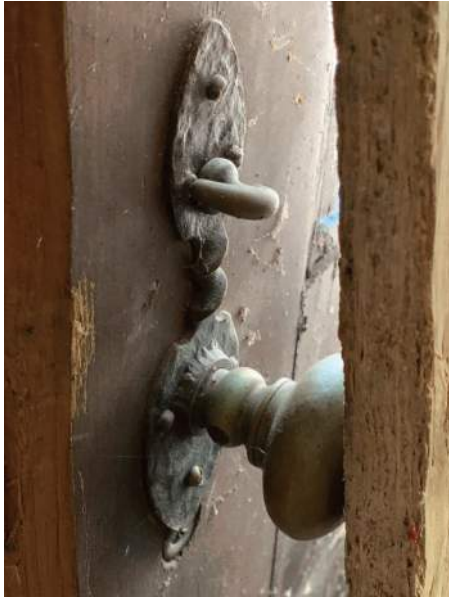
Original Hardware on Existing Front Door (Vestibule)

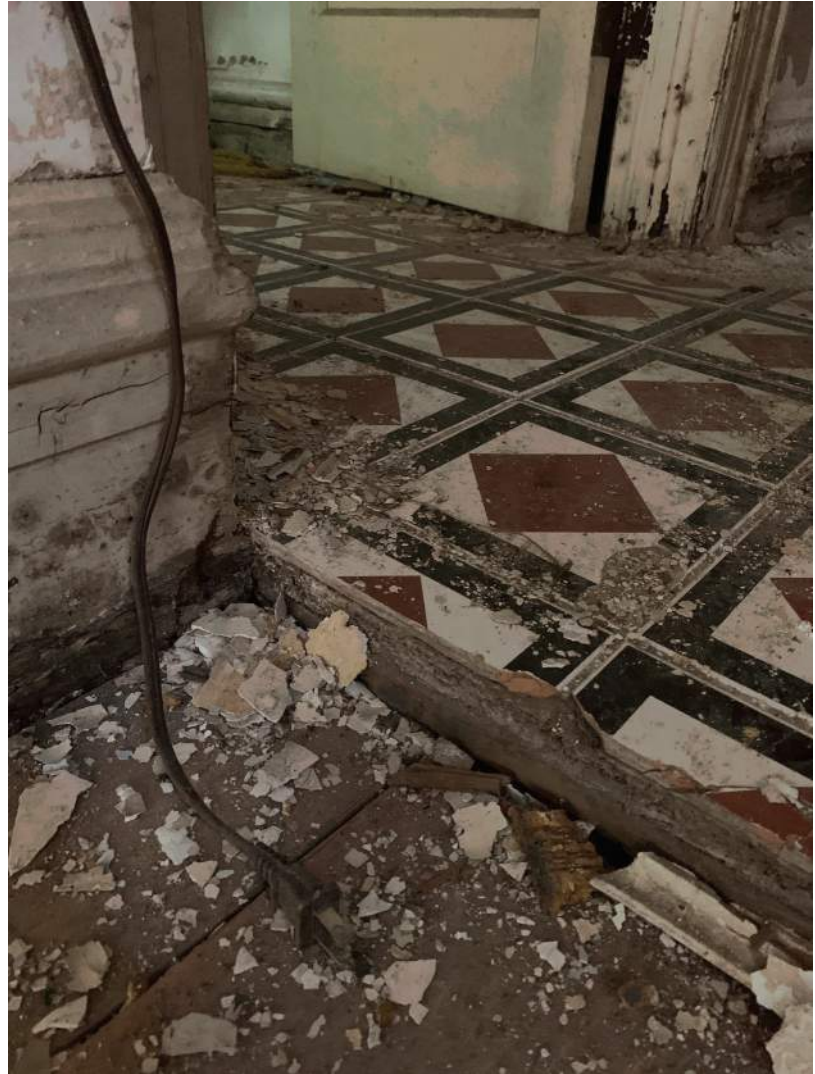
Odd Floor Level Change From Vestibule to West Living Unit

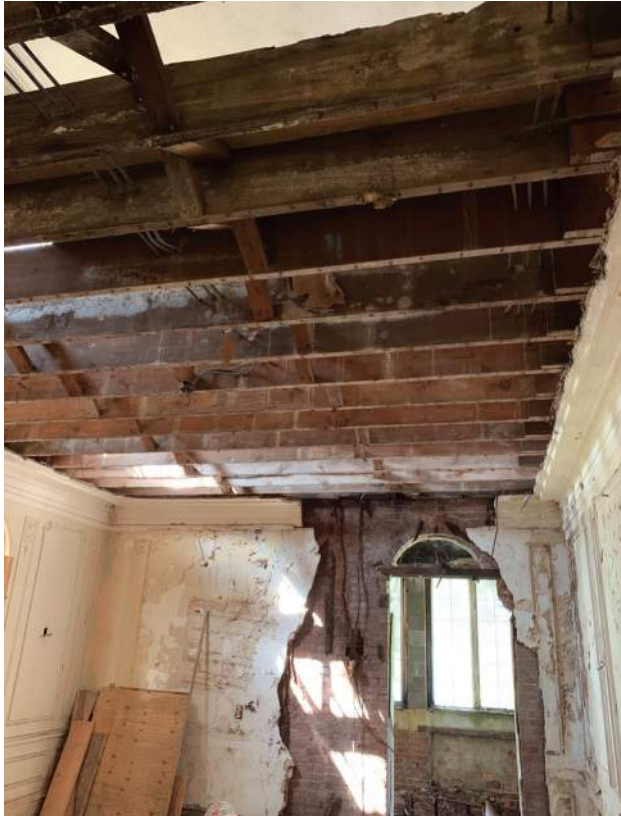
View Towards West Sunporch

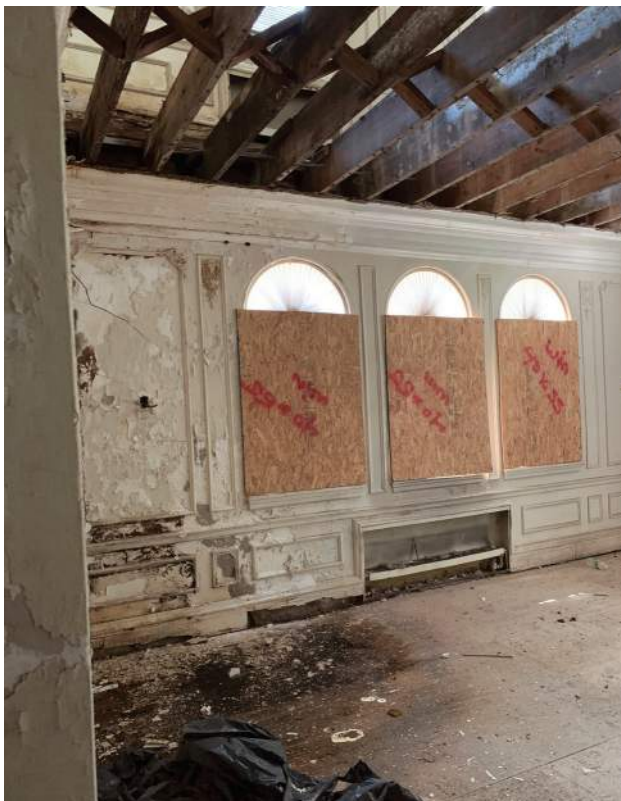
Tripartite Windows Facing Chestnut Street

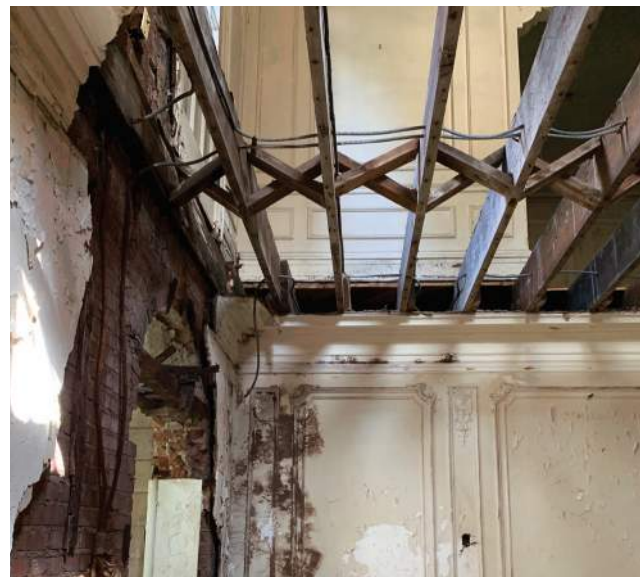
Roof Drainage Damage and View to Second Floor Level Living Area

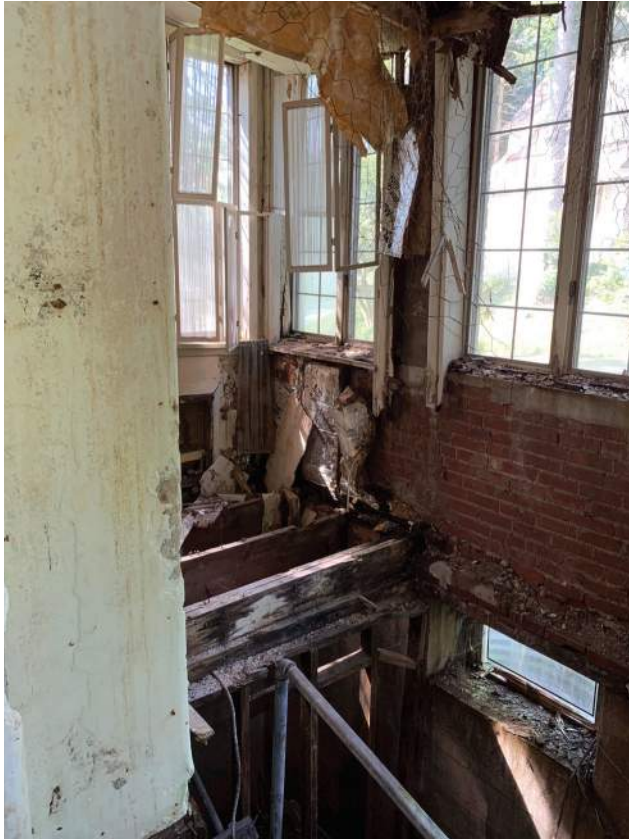
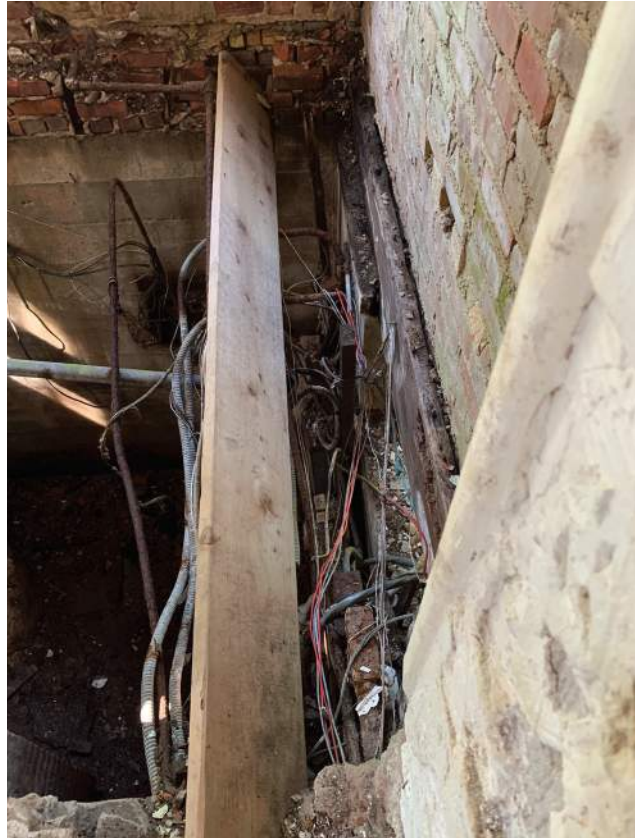
Existing Conditions - Interior, First Floor Level

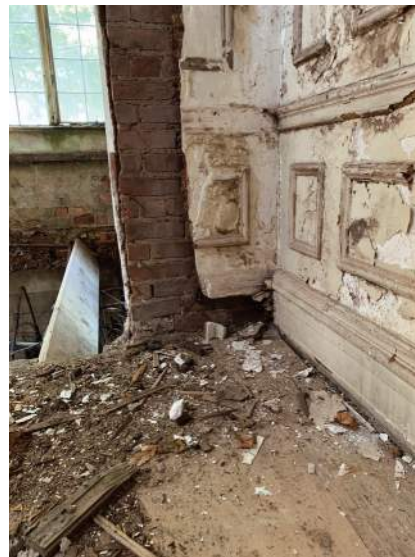
Intact Plaster Wall Panels

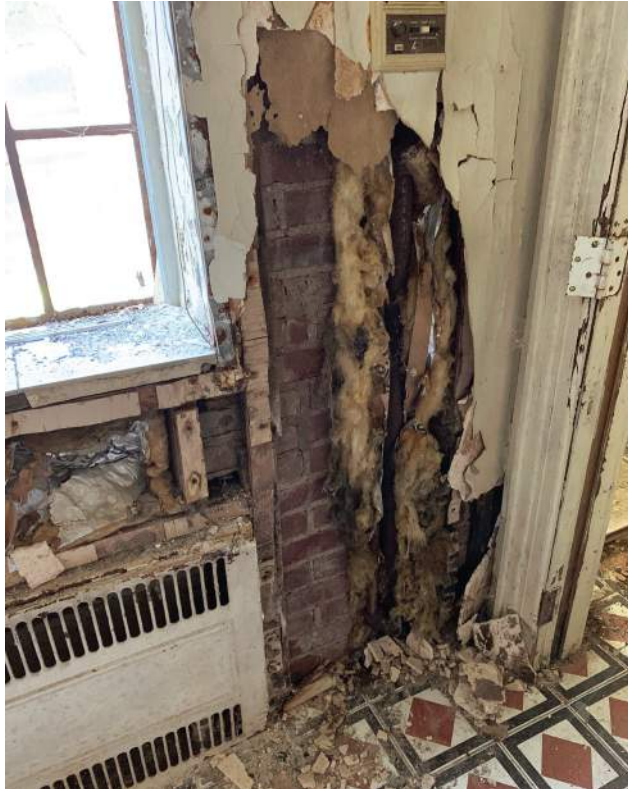
Water Damage in West Living Unit Kitchen

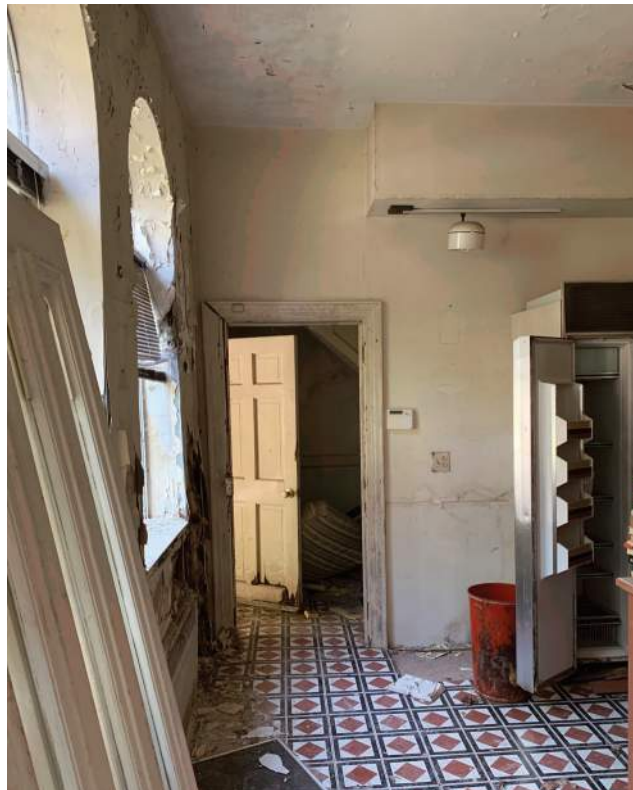
West Living Unit Kitchen

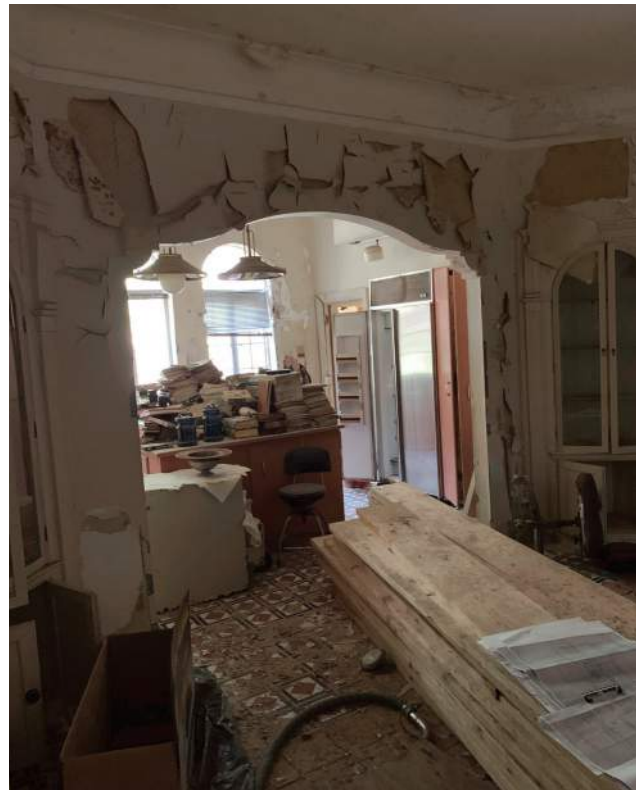
View from Dinette into Kitchen

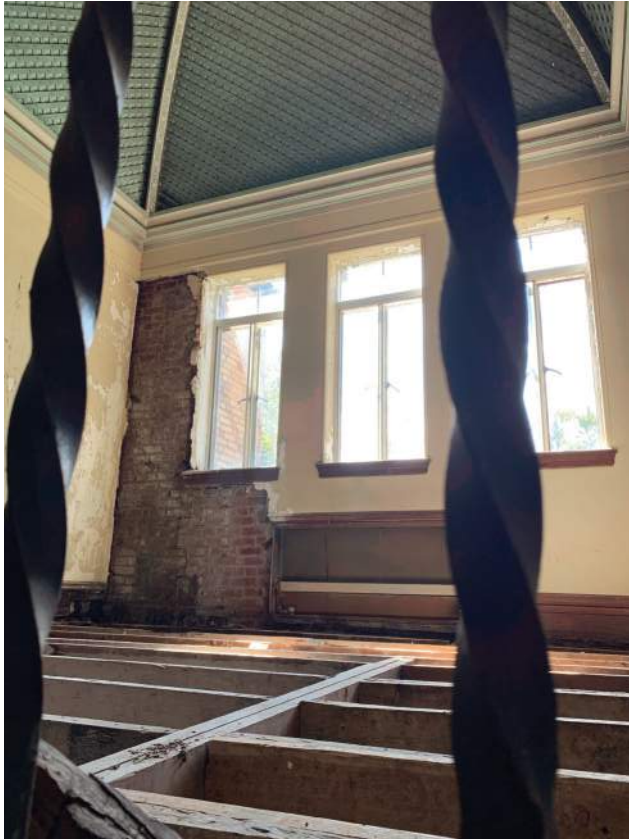
Second Level Solarium Looking Towards Chestnut Street

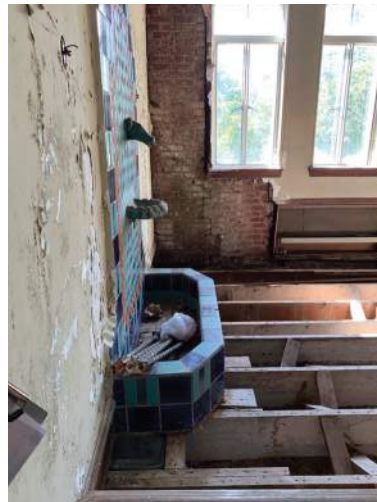
Second Level Solarium Water Feature

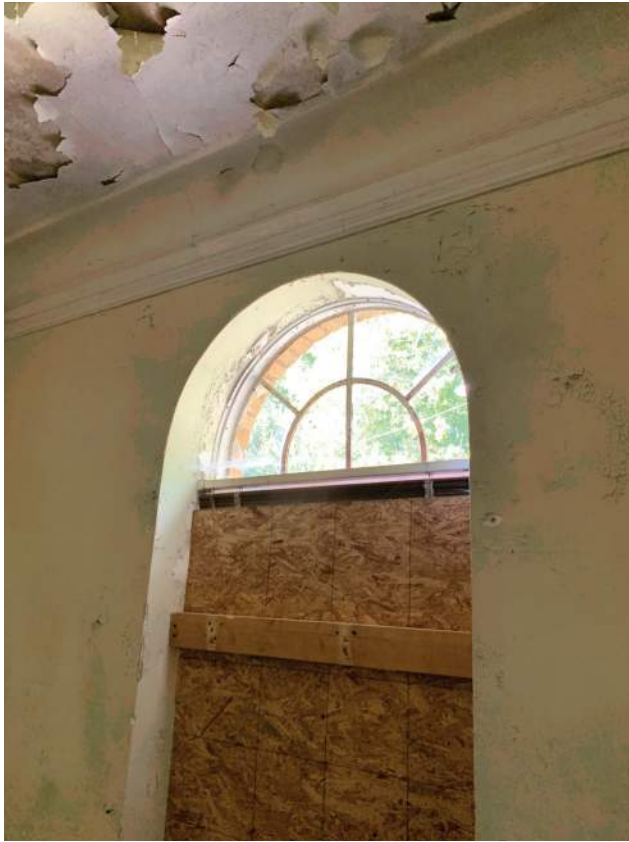
West Living Unit Bedroom

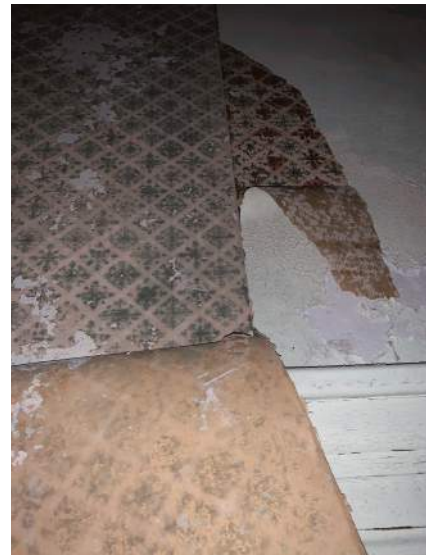
Original Wall Covering Uncovered

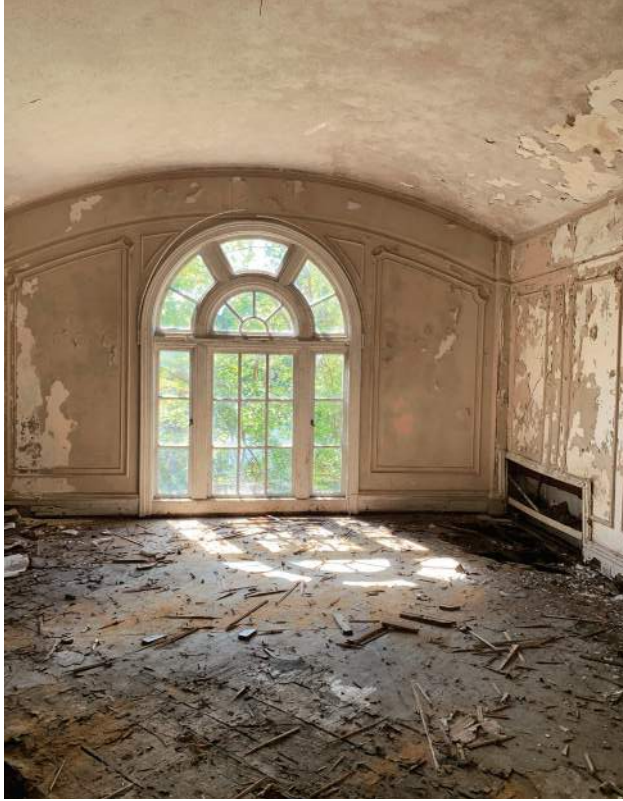
*Bedroom No. 1 Damaged Floor Around Inwall Radiator
Beneath a Roof Gable and Exterior Wall Intersection*

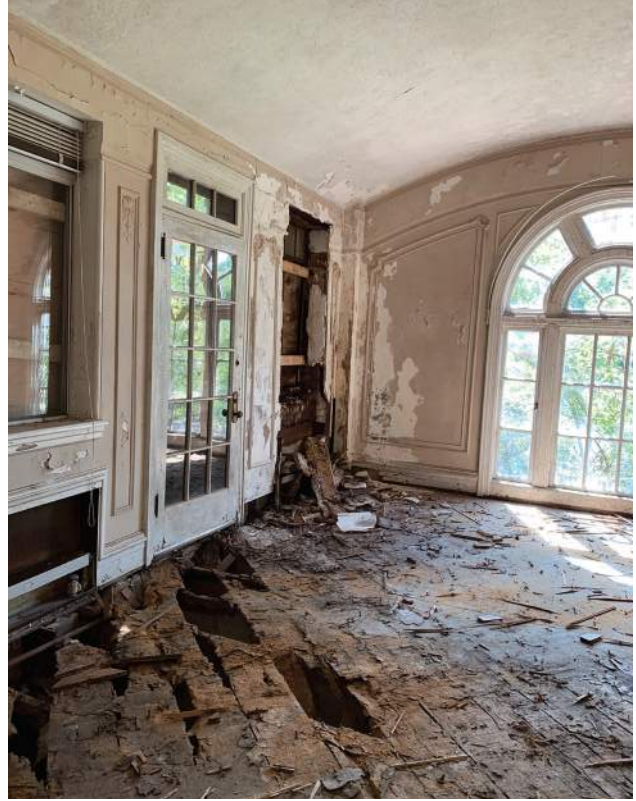
*Bedroom No. 1 Damaged Floor Along Exterior Common
Wall with Southeast Sunporch*

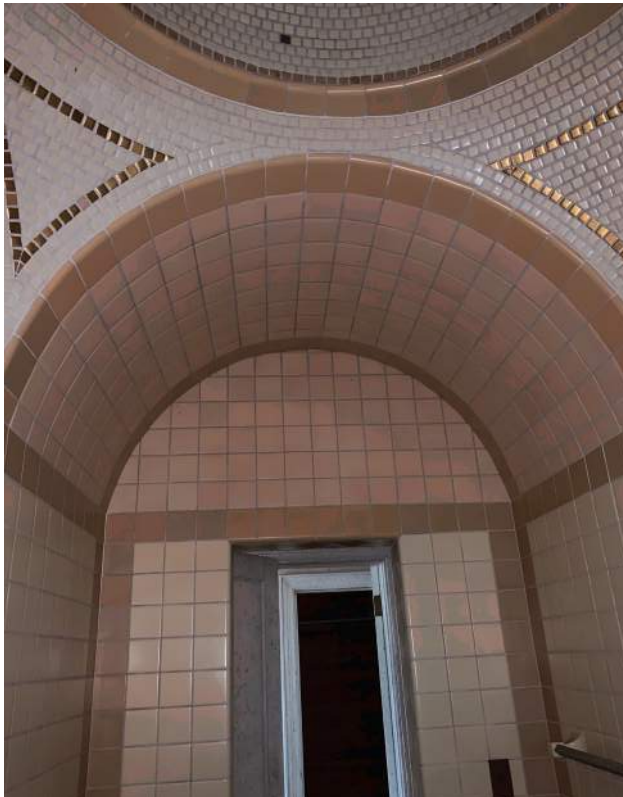
*Bedroom No. 1 Bathroom Tiled Dome Ceiling Feature,
Walls and Ceiling Arch*

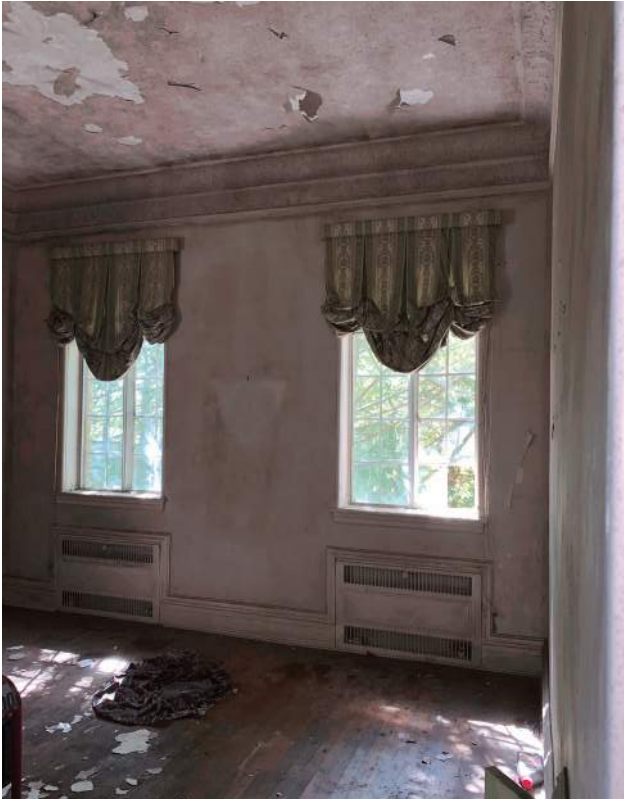
The second floor level southwest bedroom is mostly intact. It is isolated from areas such as sun porches, roof flashing or plumbing lines. Areas that show evidence of water damage pictured at left.

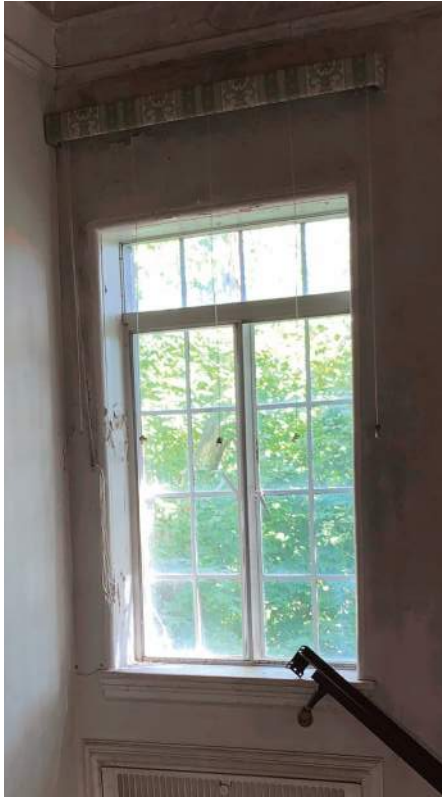
Second Floor Level Steel Casement Window with Interior Storm

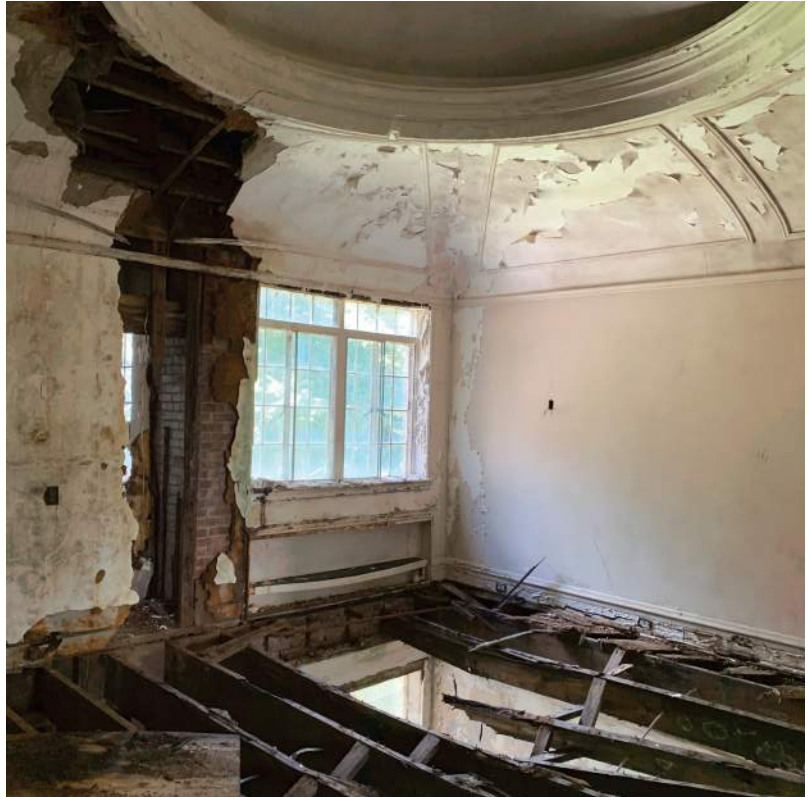
Domed Reception Room Ceiling and Wall Damage Beneath Roof Valley Flashing

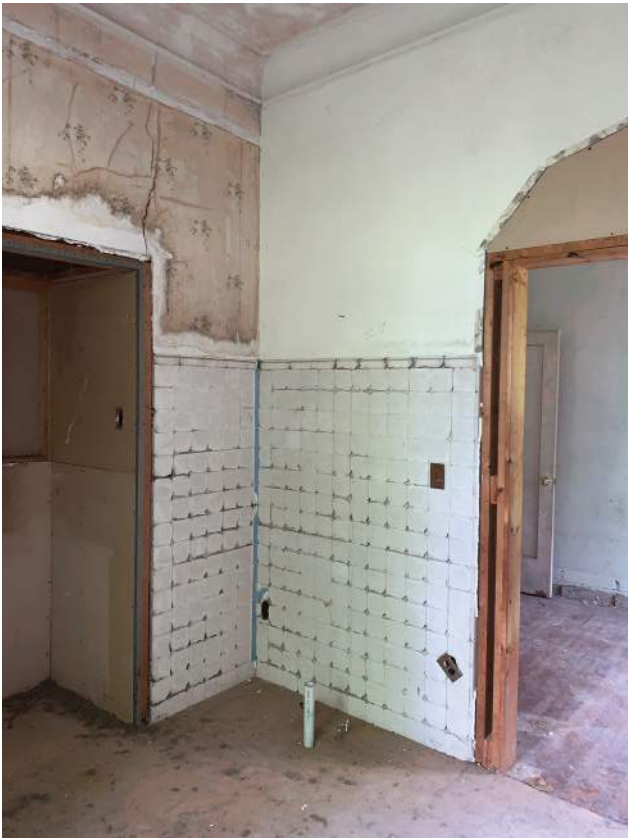
Labeled as Bedroom No. 3 on the plans, this room was divided and shows evidence of being partially tiled. The tile may be indicative of a fourth kitchen.

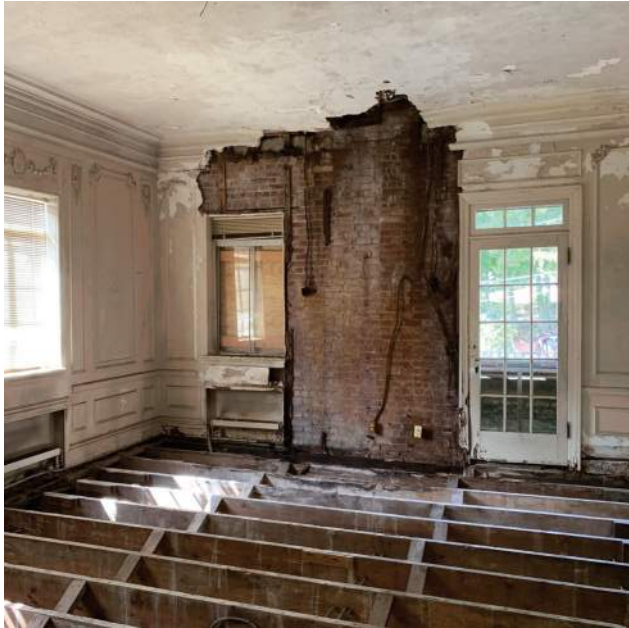
Living Room with Extensive Wall and Floor Damage Around Chimney and West Sunporch

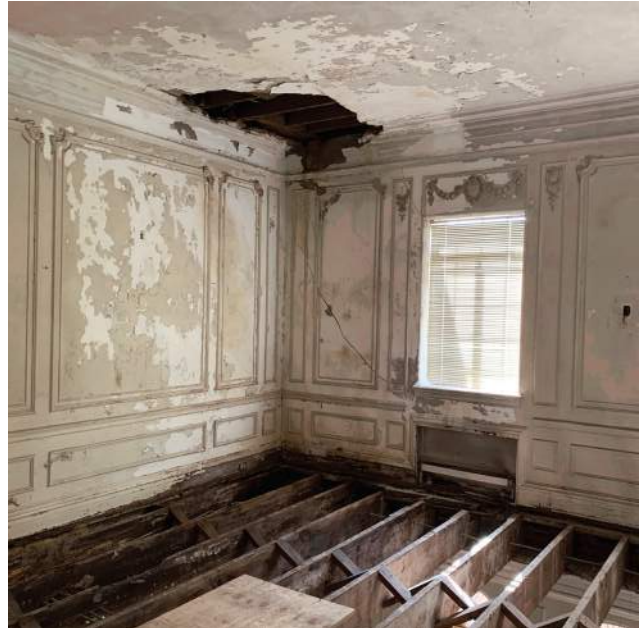
Living Room Damaged Floor Beneath a Roof Exterior Wall Intersection

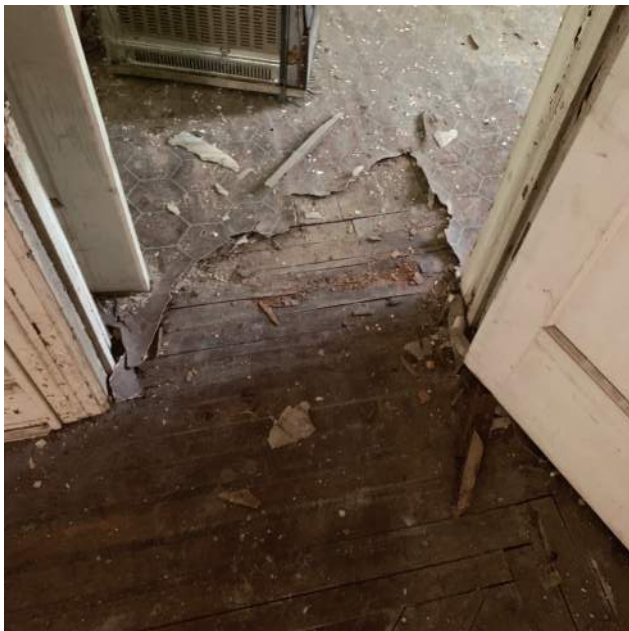
Evidence of Sheet Flooring on Top of Wood Trapping Moisture and Magnifying the Damage

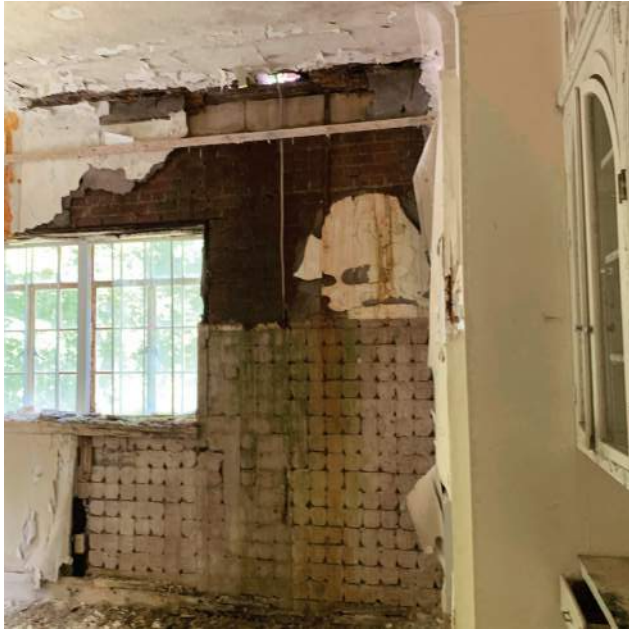
Second Floor Level North Wall of Kitchen Showing Missing Tiles and Roof Edge and Ensuing Damage

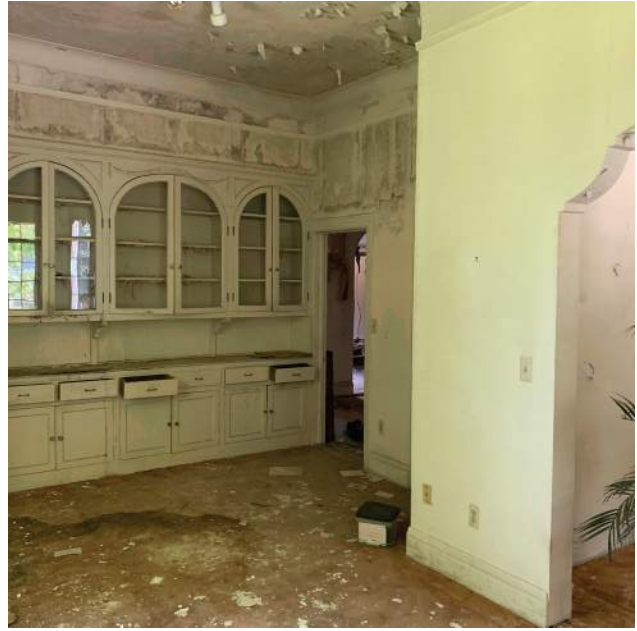
Second Floor Level Intact Original Kitchen Casework

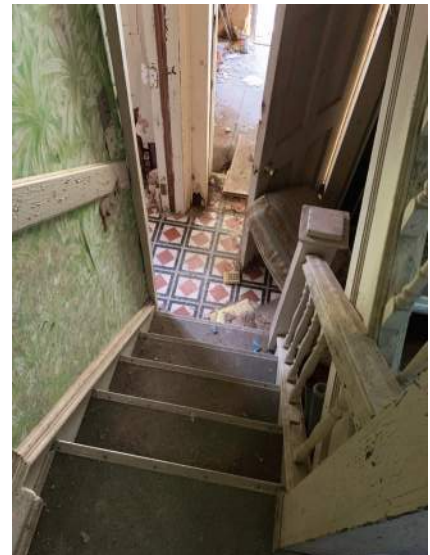
Stair Lower Run with Exit to Hadden Road

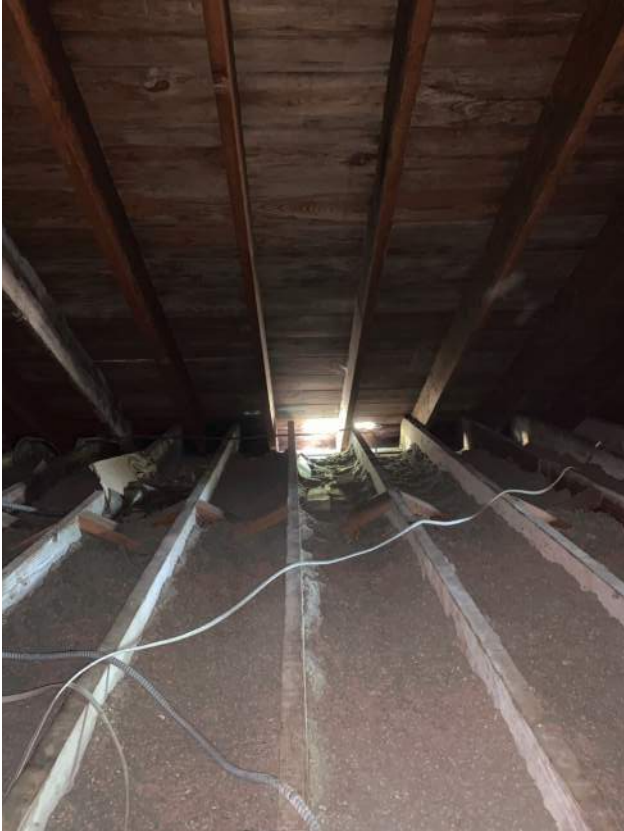
Above North Wall of Second Level Kitchen

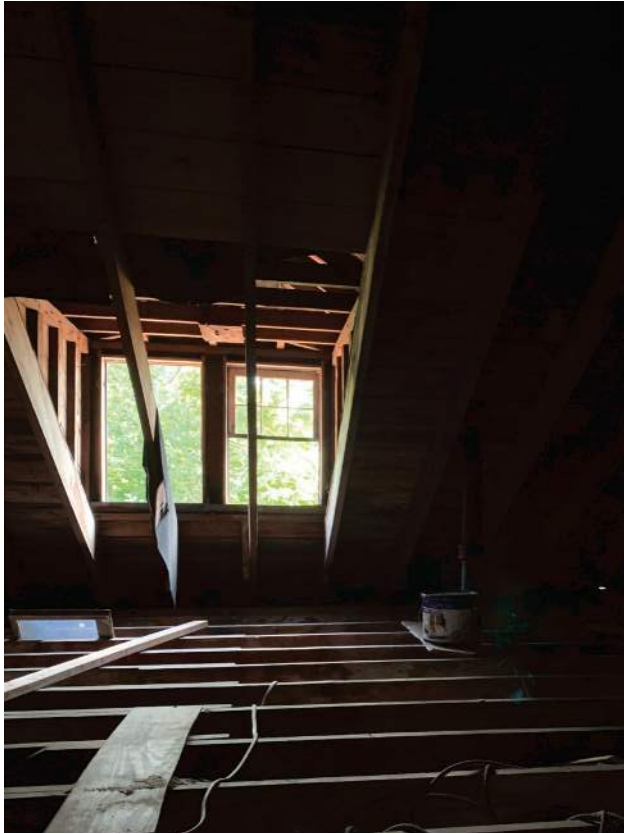
East Facing Dormer Interior View

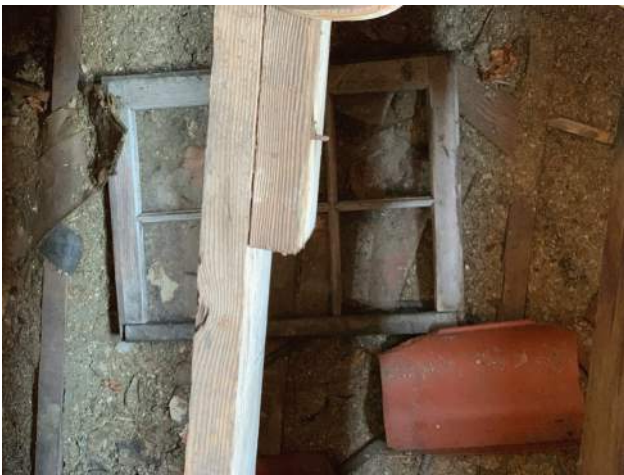
Rubble and Window Components

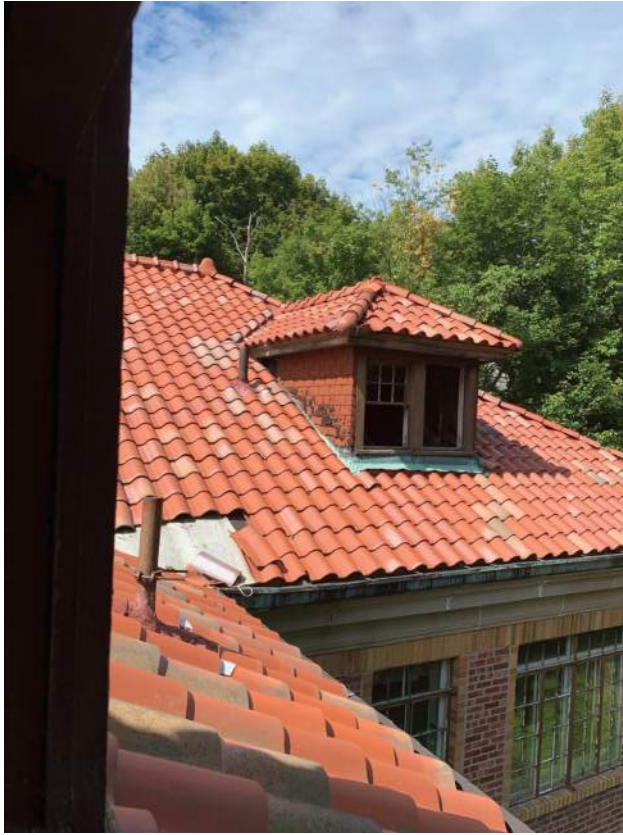
East Facing Dormer Exterior View

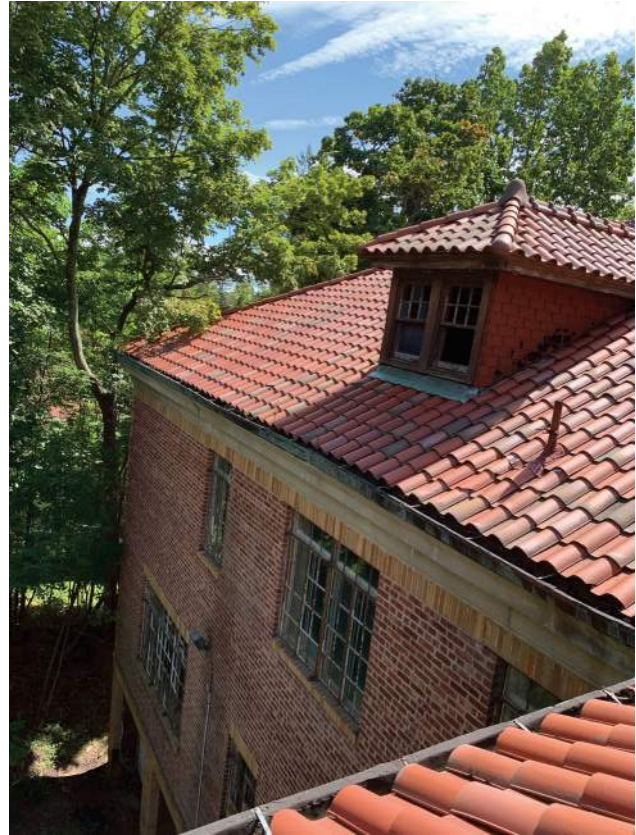
North Facing Dormer with Windows Intact

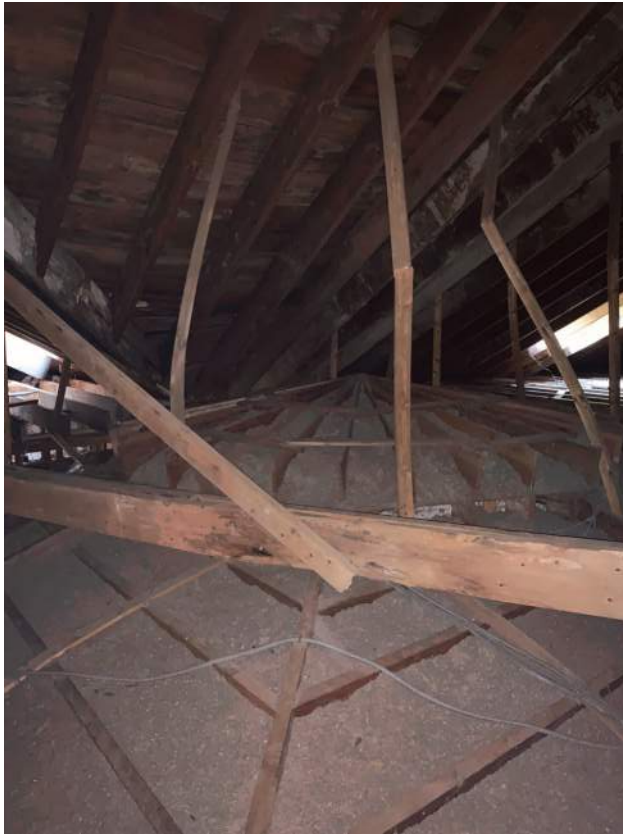
Attic Bracing Above Reception Room Dome
