**Request for Proposals to
Purchase & Redevelop
91 Chestnut Street
Liberty, NY 12754**

Date Issued: Friday October 7, 2022

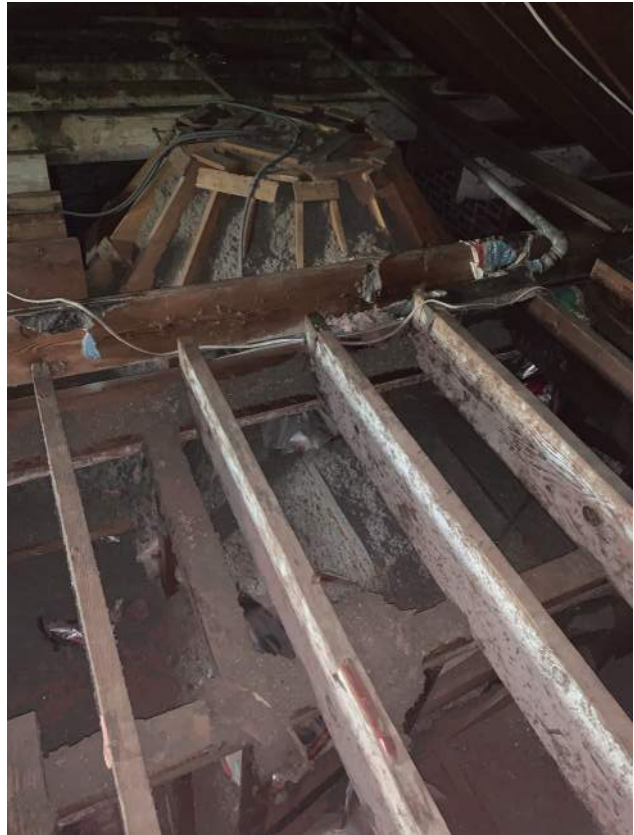
Bedroom No. 1 Framing for Bathroom Dome Ceiling

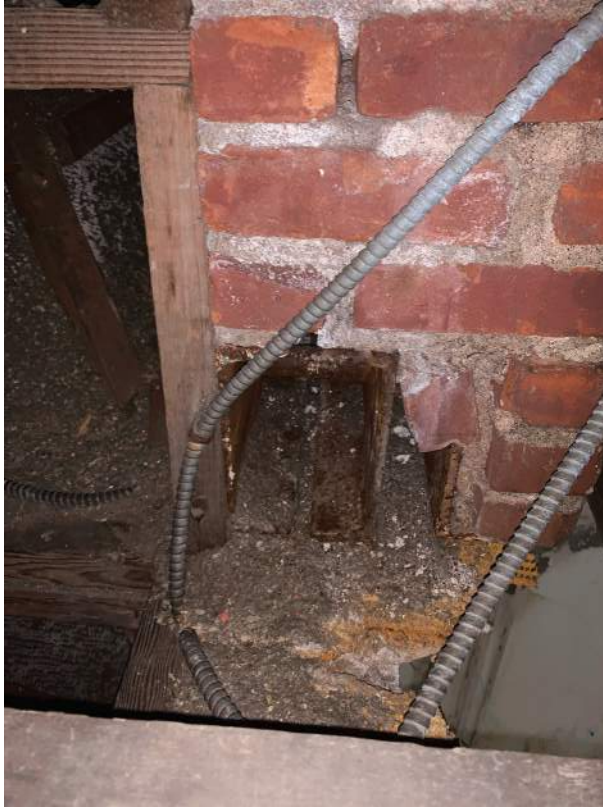
Steel Channel and Angle Sections

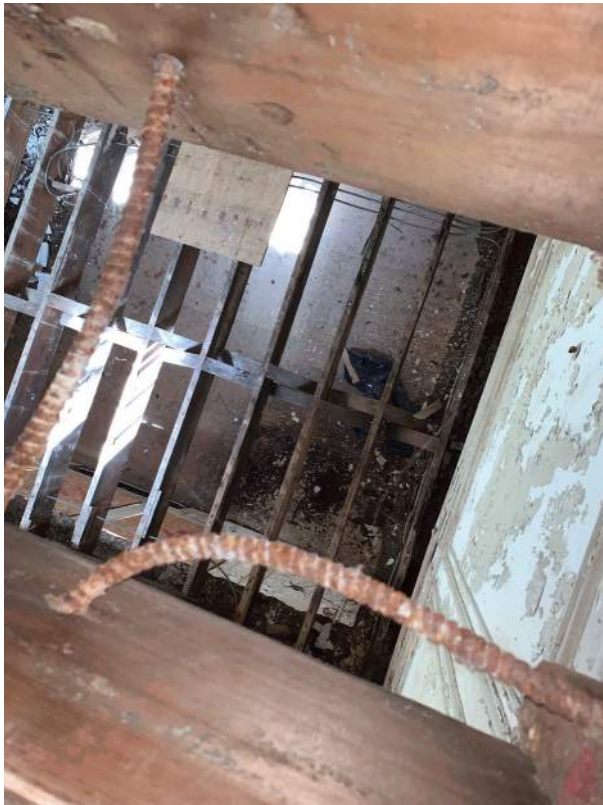
View to First Floor Level and Damage at Roof and Exterior Wall Intersection

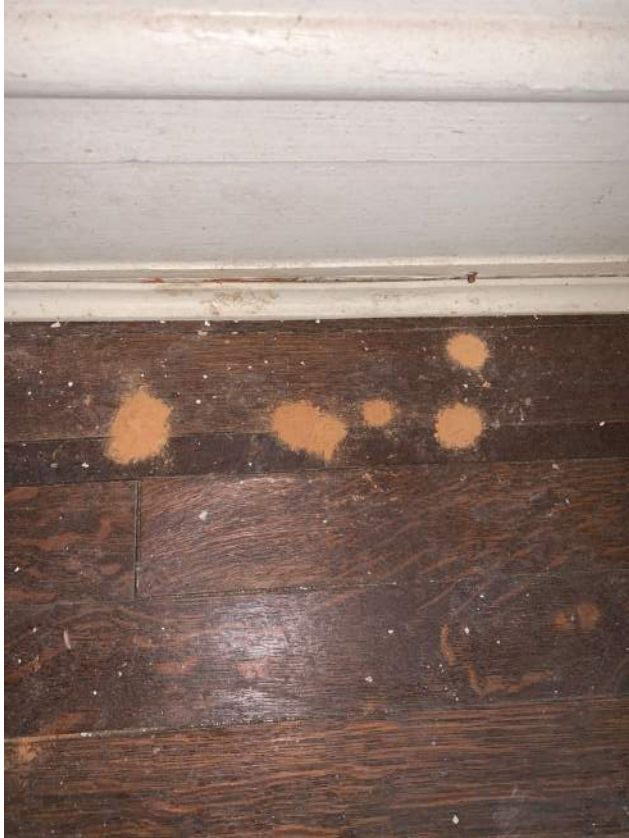
A Location in the East Wing of the Second Floor Level, Where the Flooring and Walls Seem to be Original and Intact, Shows Signs of Powder Post Beetle Activity

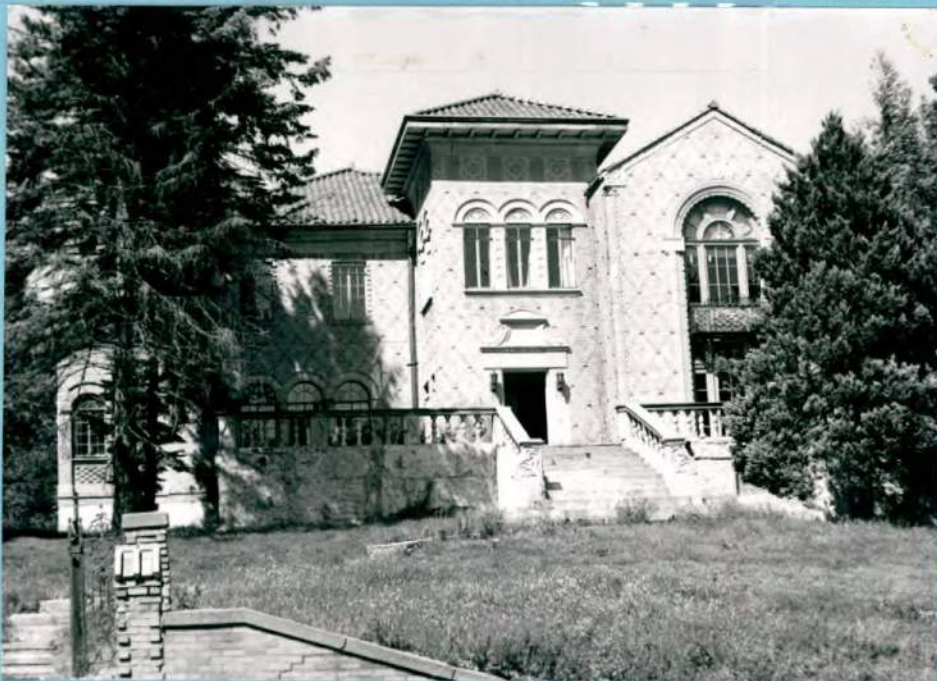
14. THREATS TO BUILDING: a. none known b. zoning c. roads
 d. developers e. deterioration
 f. other: vandalism
15. RELATED OUTBUILDINGS AND PROPERTY:
 a. barn b. carriage house c. garage
 d. privy e. shed f. greenhouse
 g. shop h. gardens
 i. landscape features: not maintained
 j. other: _____
16. SURROUNDINGS OF THE BUILDING (check more than one if necessary):
 a. open land b. woodland
 c. scattered buildings
 d. densely built-up e. commercial
 f. industrial g. residential
 h. other: _____

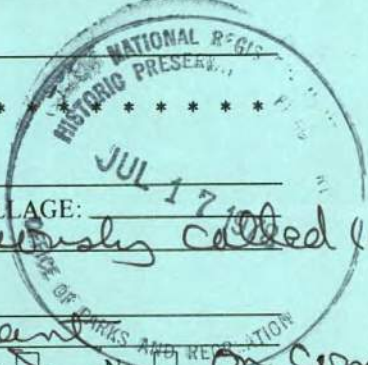
1. BUILDING NAME(S): Jaeger Estate
2. COUNTY: Sullivan TOWN/CITY: Liberty VILLAGE: _____
3. STREET LOCATION: 91 Chestnut (Previously called 100)
4. OWNERSHIP: a. public b. private
5. PRESENT OWNER: above ADDRESS: Vacant
6. USE: Original: Summer residence Present: On corner
7. ACCESSIBILITY TO PUBLIC: Exterior visible from public road: Yes No
Interior accessible: Explain large french doors
massive patios.

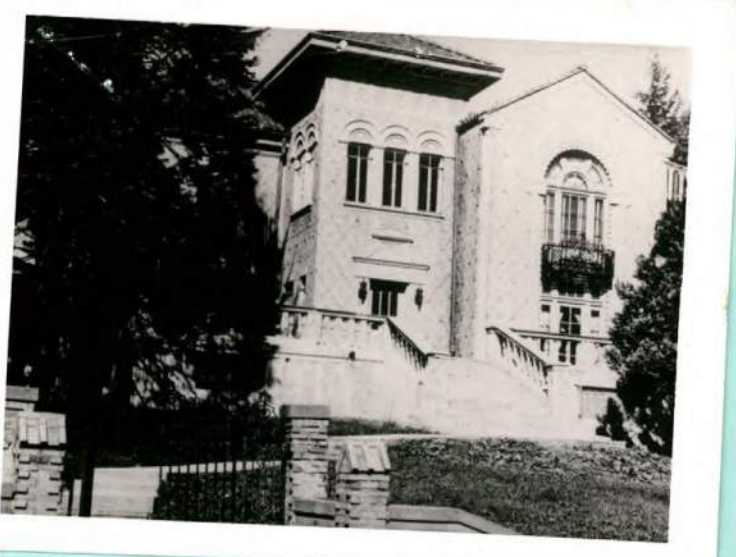
8. BUILDING MATERIAL: a. clapboard b. stone c. brick d. board and batten
e. cobblestone f. shingles g. stucco other: tile roof, stained cement, wrought iron
9. STRUCTURAL SYSTEM: a. wood frame with interlocking joints
b. wood frame with light members
c. masonry load bearing walls
d. metal (explain) _____
e. other _____
10. CONDITION: a. excellent b. good c. fair d. deteriorated
11. INTEGRITY: a. original site b. moved if so, when? _____
c. list major alterations and dates (if known): remodeled kitchens (2) of 4 in house.
