## R-20-02: REDEVELOPMENT OF MONTICELLO MANOR

**Phase II Environmental  
Site Assessment (ESA)**

**Monticello Manor  
15 High Street  
Monticello, New York  
Sullivan County**

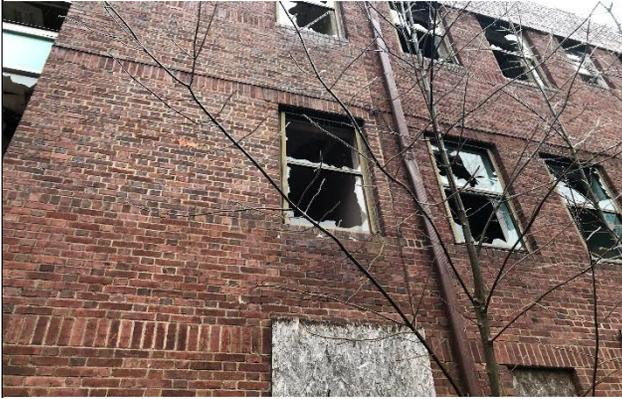
**Photograph # 1**  
Typical lintels showing signs of rust and deflections.

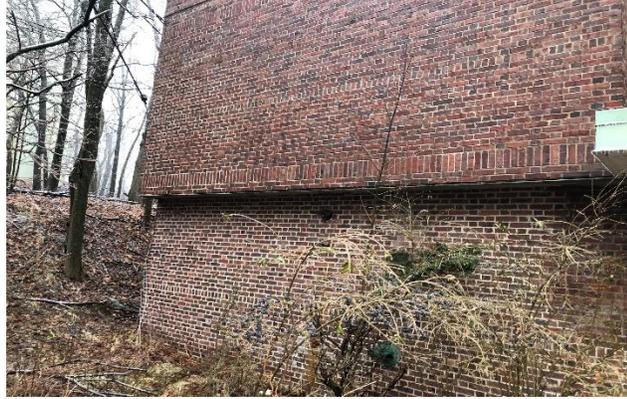
**Photograph # 2**  
Overhang in front of building showing signs of deflection and rust.

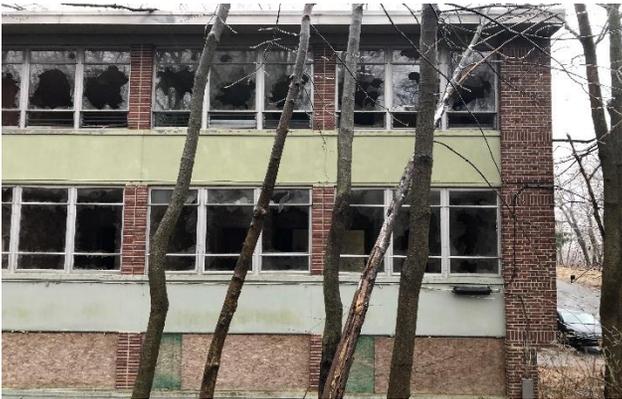
**Photograph # 3**  
East Building- Broken windows

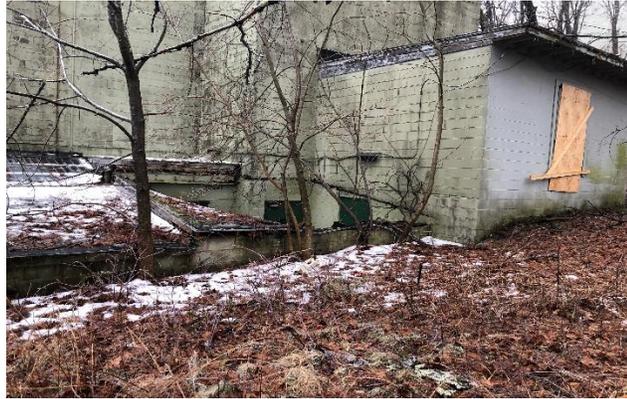
**Photograph # 4**  
East Building-Collapsed roof in stairwell entry

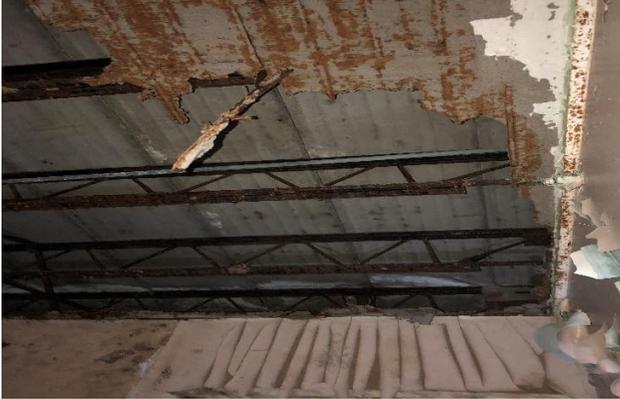
**Photograph # 5**  
Main Building-1<sup>st</sup> Floor- Steel joists and concrete planks.

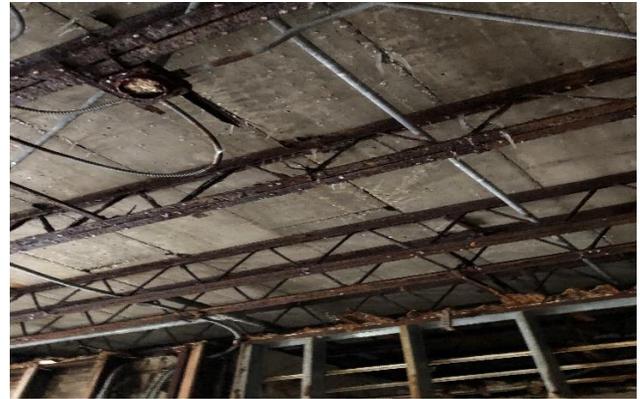
**Photograph # 6**  
Main Building-2<sup>nd</sup> Floor- Rusted joists, water coming through planks

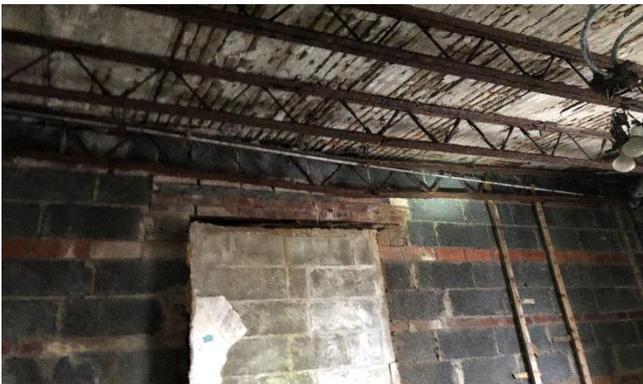
**Photograph # 7**  
Main Building-3<sup>rd</sup> Floor- Broken joists, exposed rebar

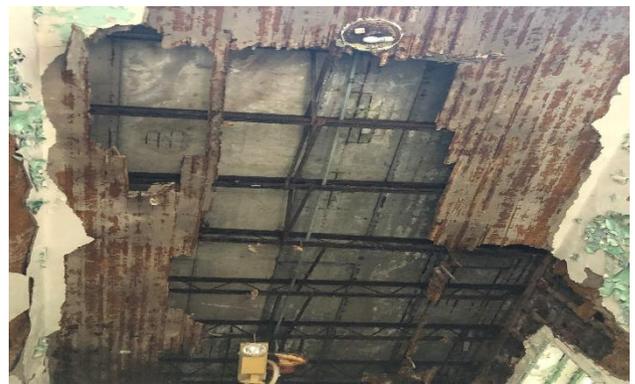
**Photograph # 8**  
Main Building-Stairwell Roof- exposed rebar, rusted joists

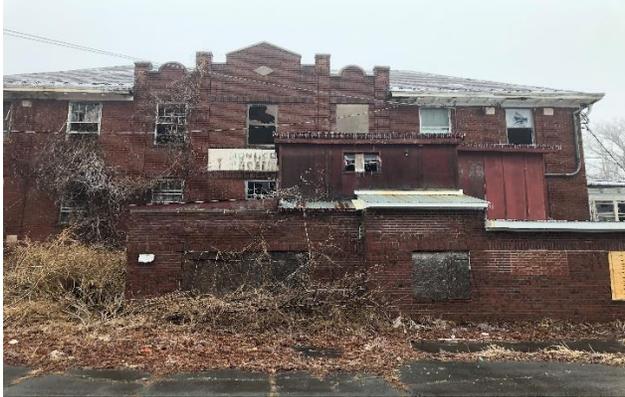
**Photograph # 9**  
East Building-Vegetation growing on building

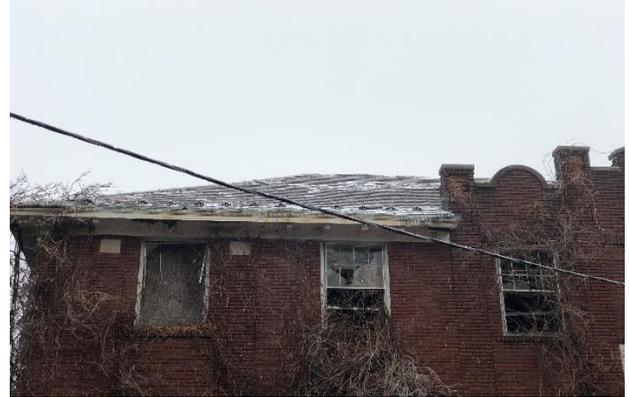
**Photograph # 10**  
East Building-Roof caved in

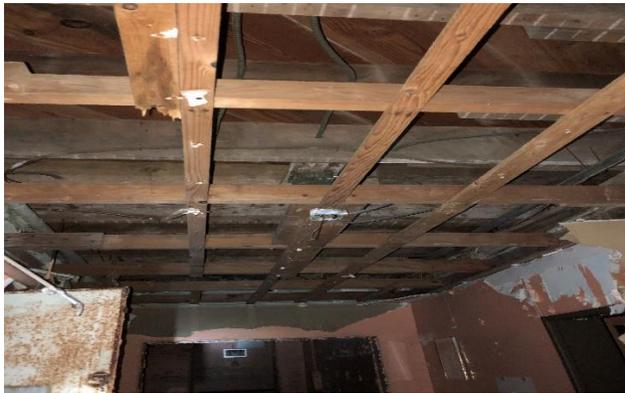
**Photograph # 11**  
East Building- 1<sup>st</sup> Floor- Wood framing

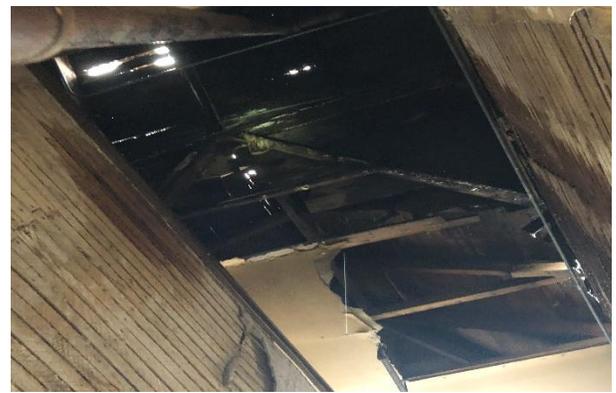
**Photograph # 12**  
East Building-Roof structure rotted and compromised
